MONROE COUNTY HISTORIC JAIL

HISTORIC STRUCTURES REPORT

January 2018

By: *Bender & Associates Architects p.a.*
410 Angela Street
Key West, Florida 33040

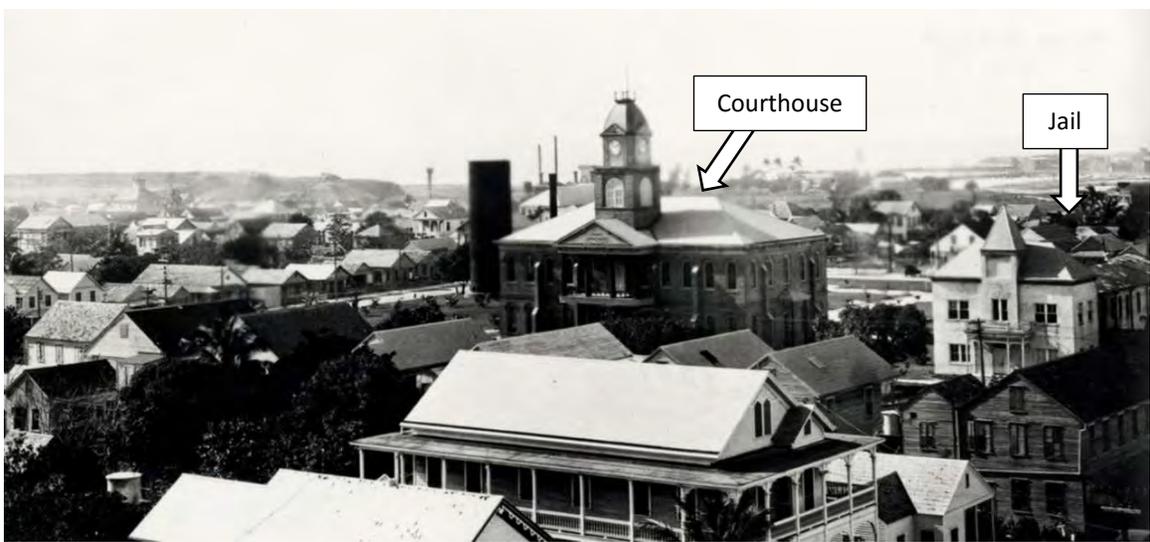
1926 view toward Jackson Square from the La Concha Hotel. Visible are the courthouse, jail and waterworks standpipe. Note that the exterior of the jail has been covered in stucco. (Keys Public Libraries)

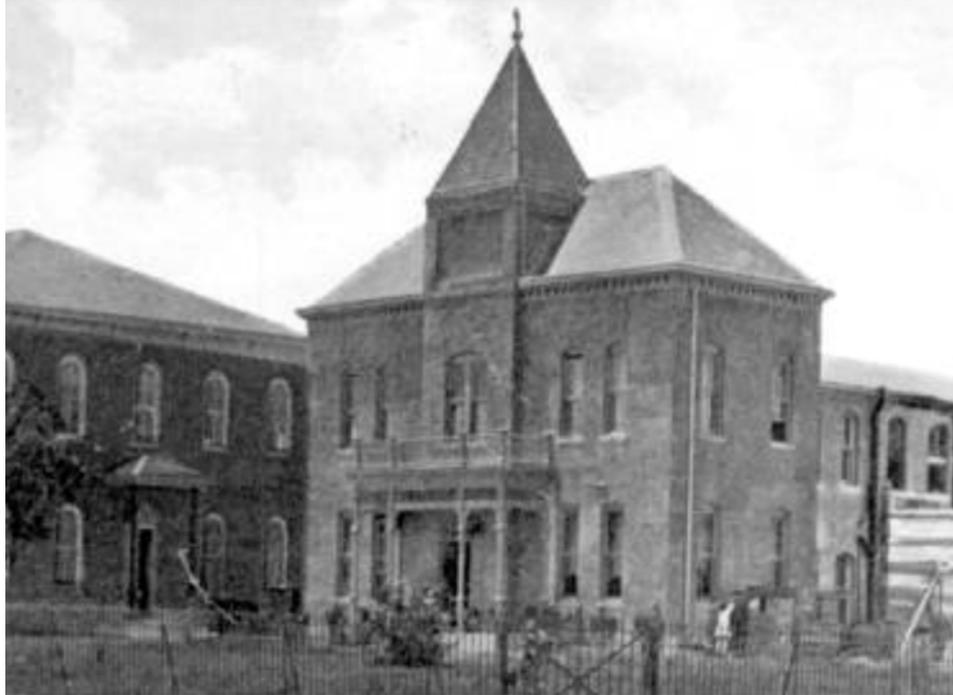
The Monroe County Jail, built in 1892 by the Pauly Jail Building Company.
(Keys Public Libraries)

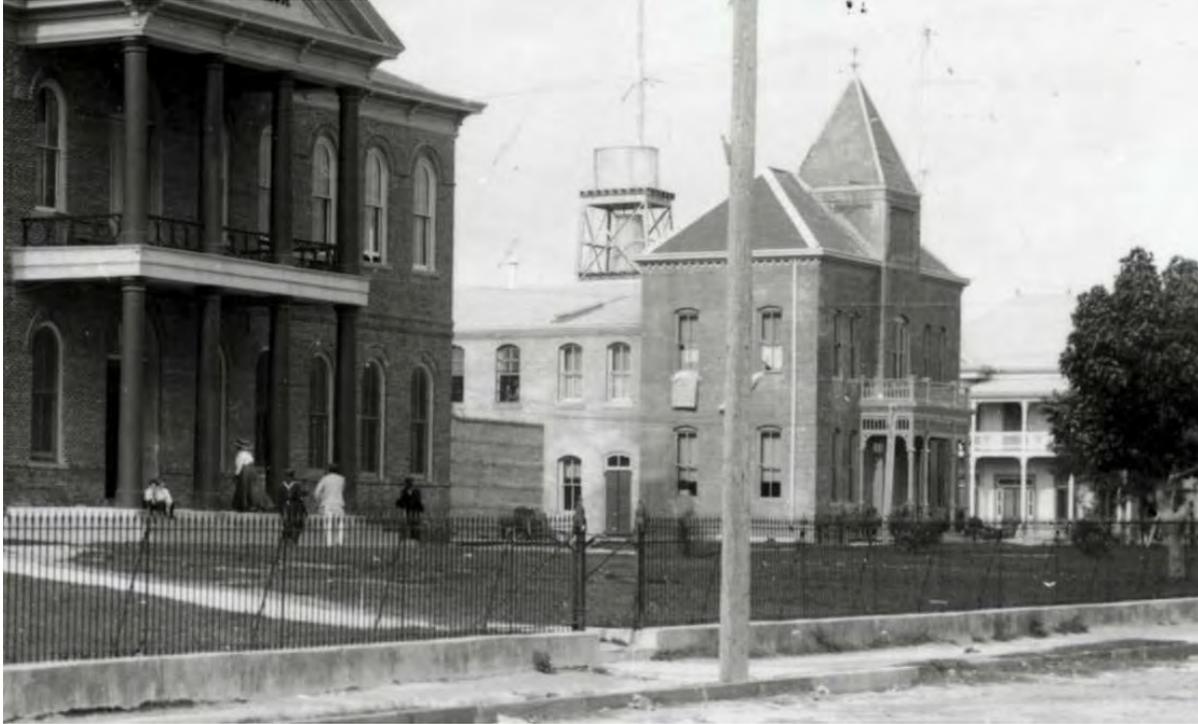
Circa 1915 photo of the courthouse and jail. Note that the jail chimneys have been removed and the wall has been moved toward the rear as compared with the photo of page 36. (Keys Public Libraries)

A high resolution photograph taken of the jail in 1915 provides additional detail about the jail following its enlargement. As discussed on the previous page, the line of the concrete block wall facing toward Whitehead Street was shifted back, demonstrating that the portion of the building where prisoners were confined had been shifted to the rear addition. The area in front of the wall was now part of the sheriff and jailer's residence. However, by comparing this photo with the 1912 Sanborn map, it indicates that a small portion of the 1892 brick jail was retained in the area behind the wall. (See photo enlargement following page)

To harmonize the new addition with the older portion at the rear of the jail, a coat of stucco was applied over the brick. Other changes that are evident include the removal of the jail's chimneys. A new water tower has been constructed to supply water to the jail. The far right of the photo also appears to show the kapok tree which now stands at Jackson Square.

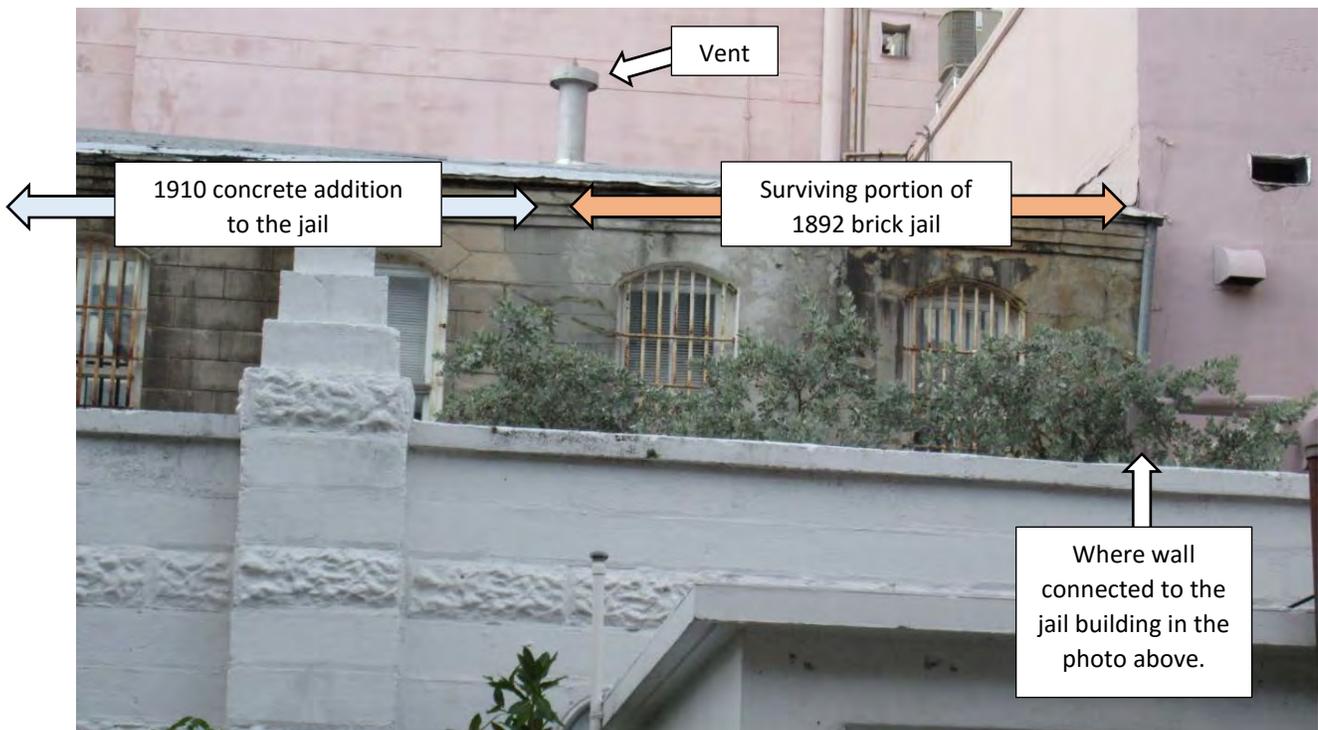
Comparison of a detail from the circa 1915 photo with a 2017 photo of the same (south) façade. Note the discoloration in the stucco where the concrete addition meets the brick portion of the 1892 jail.

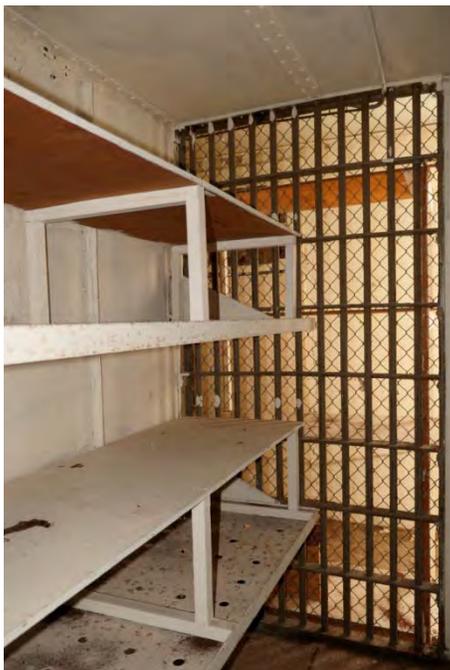
2017 photo of a cell inside the Monroe County Jail

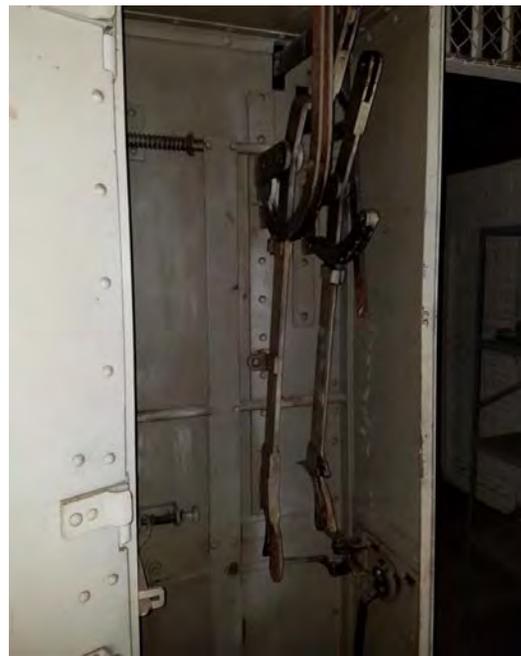
2017 photo inside the Monroe County Jail

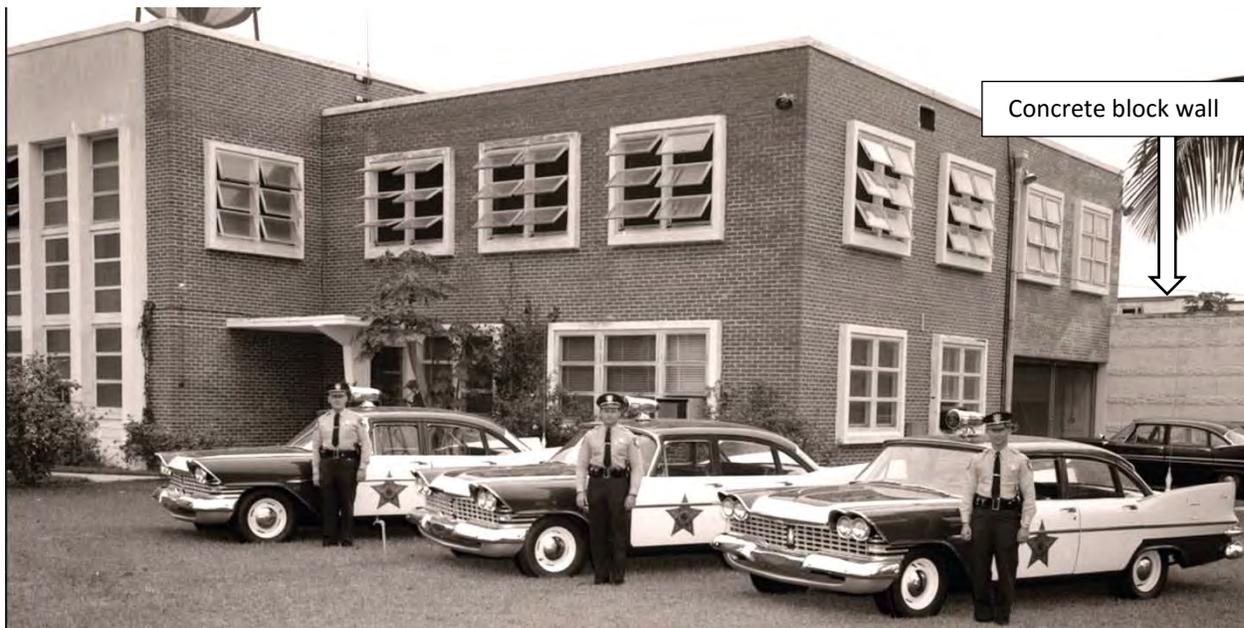
Circa 1960 view of the Monroe County Sheriff's Office and Jail. Note the rear of the building was constructed flush with the old concrete wall of the prior jail. (Florida Keys Public Libraries)

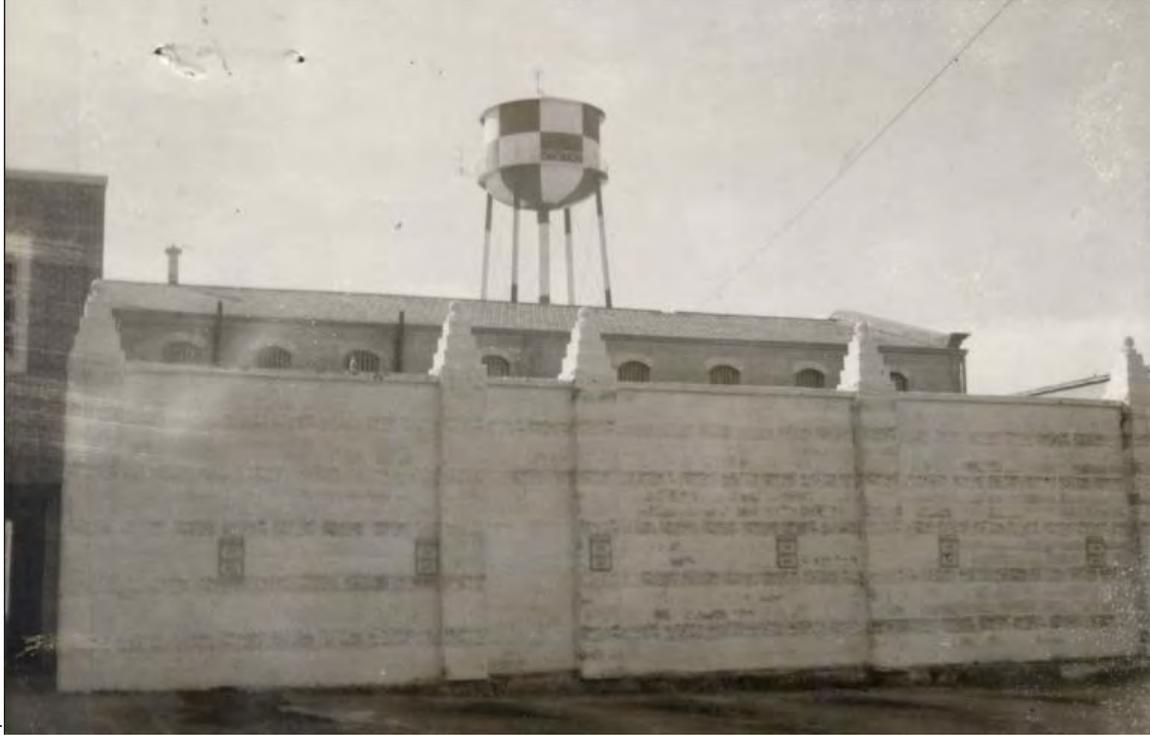
Historic photos show the old cell block was physically attached to the 1952 sheriff's office at the second story, while a covered passage ran between the buildings at the first story. At this time, all of the concrete block wall constructed in 1907 appears to have been retained.

Circa 1960 view of the jail and wall at the junction where it met the Sheriff's office. (Florida Keys Public Libraries)

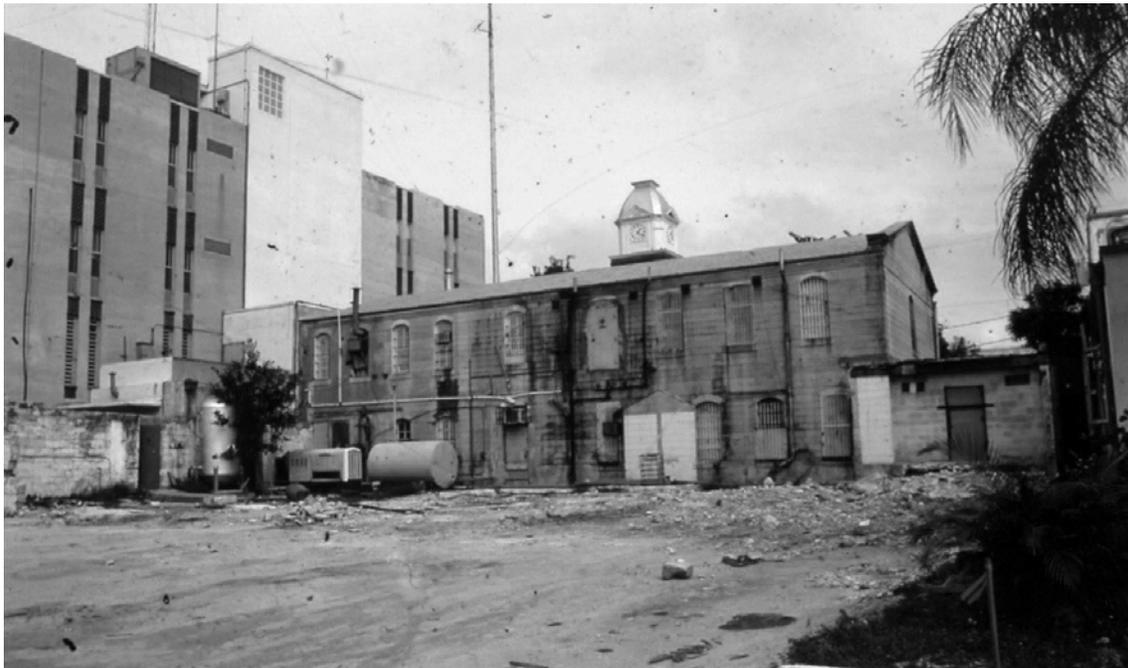
1984 view from Fleming Street toward the side of the jail. (Raymond L. Blazeovic / Keys Public Library)

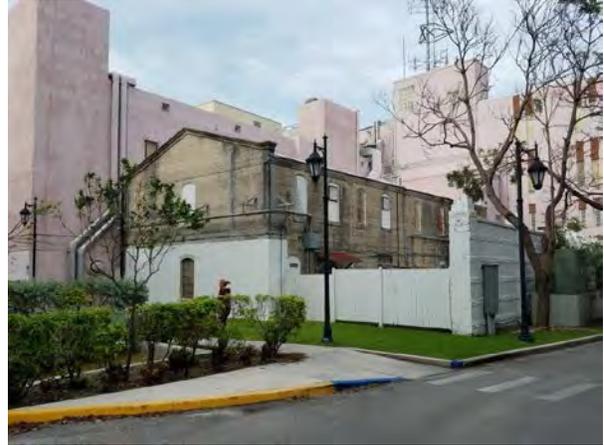
This general view of the historic Monroe County Jail is taken from the southwest. Note the close proximity of adjacent buildings at left and right. The historic prison wall can be seen at far right.

The historic jail is a significant building and worthy of preservation. The structure is in relatively good condition, although the finishes are worn at both interior and exterior. The other sections of this report outline the more specific recommendations for the building, but in short, the building should be cleaned of all conduit, wiring, piping and brackets, spalling should be repaired, the window openings and windows should be restored, the roof should be replaced, the interiors should be cleaned, patched and painted, and new mechanical, electrical and plumbing systems should be installed.

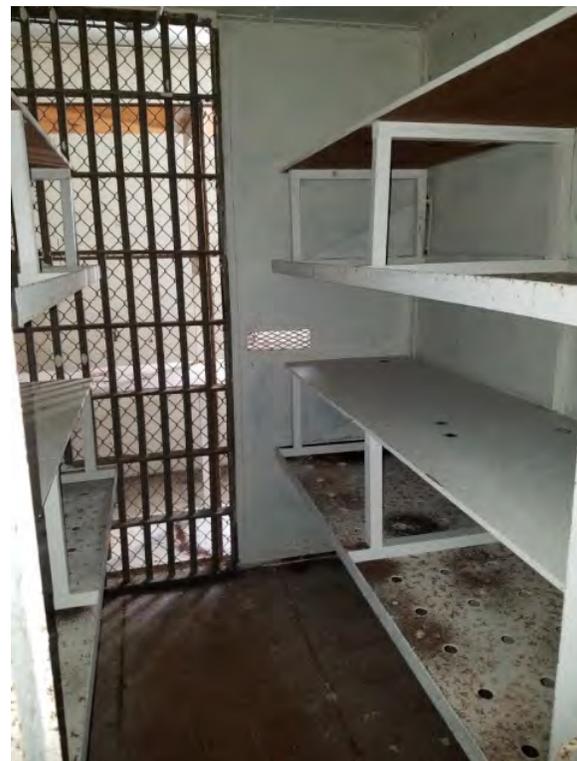
The building still contains original prison cells dating from the early 20th century.

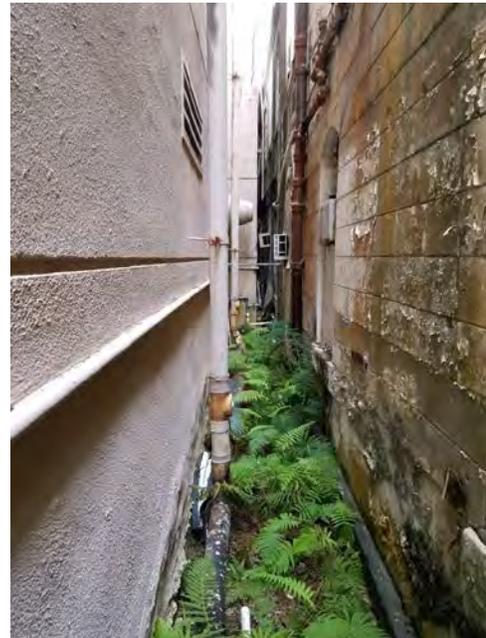
View of the alley at the north side of the building. The adjacent four story building is only 40" away from the jail building. Note the heavy organic growth, peeling paint and moisture buildup in this alley.

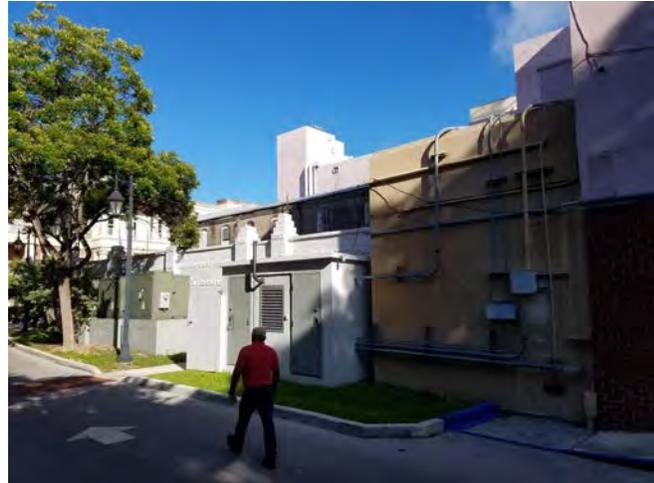
View of the south side of the jail building. The building can barely be seen on the site; its view is blocked by newer buildings, the historic prison wall, and several outbuildings. The building, which once fronted on Whitehead Street, is now completely hidden by the 5 story 1965 courthouse building seen at right.

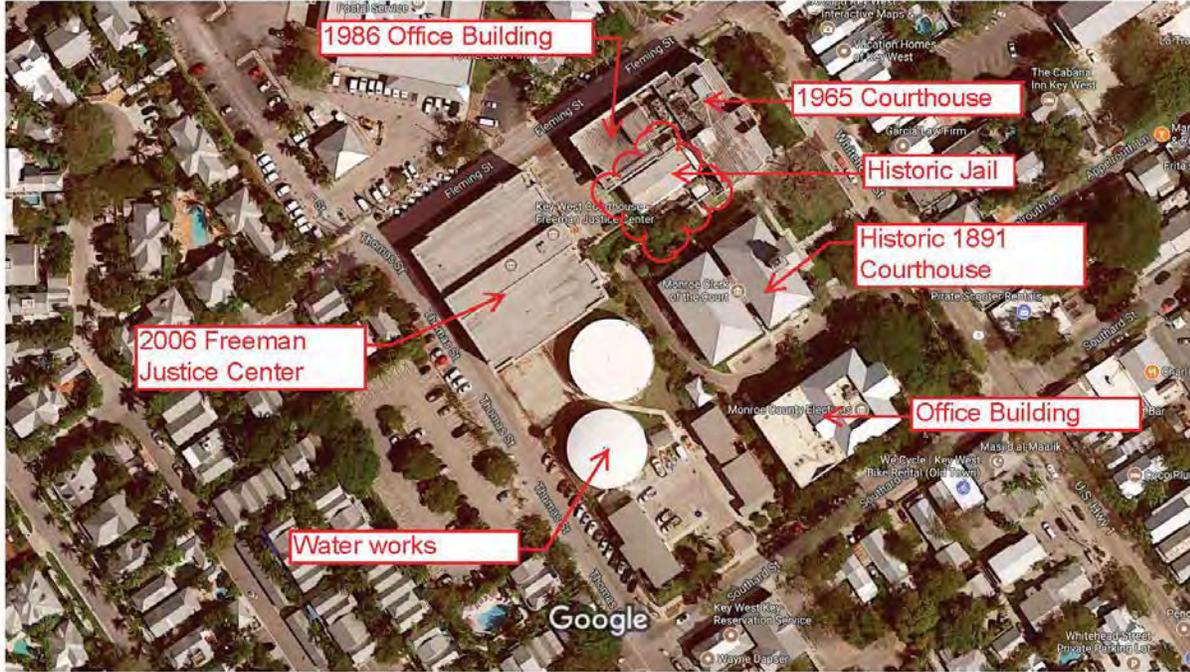
This 2017 aerial view shows the entire city block where the historic jail is located. The jail is clouded on this map. The close proximity of the adjacent buildings can be seen.

of the building, and the 1980s office building to the north, restoring some street presence to the jail building. After this demolition is complete, serious consideration should be given to rebuilding the front portion of the jail which was demolished in the 1950's. This report was commissioned to assist in finalizing these plans.

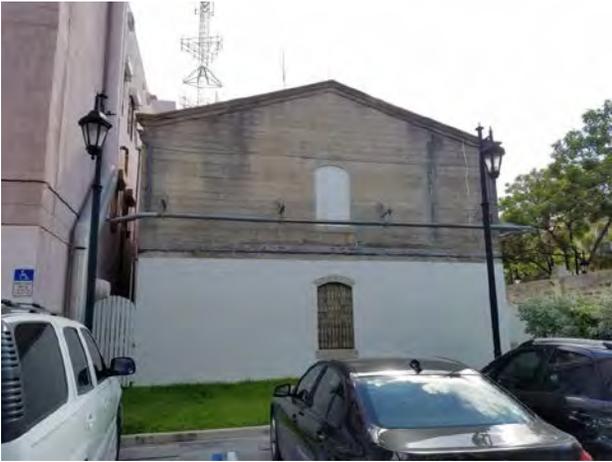
The west façade of the historic jail. This is the rear of the original building, and is the only façade clearly visible from the public right of way. It is fronted by a lawn and a parking lot. Note the large three story building to the left. This building, slated for demolition, is a mere 40" away from the jail, creating a small alley.

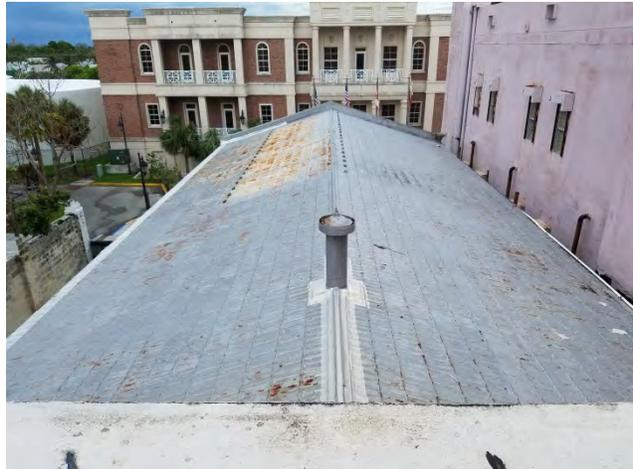
The metal shingle roof, looking west. Note historic attic vent.

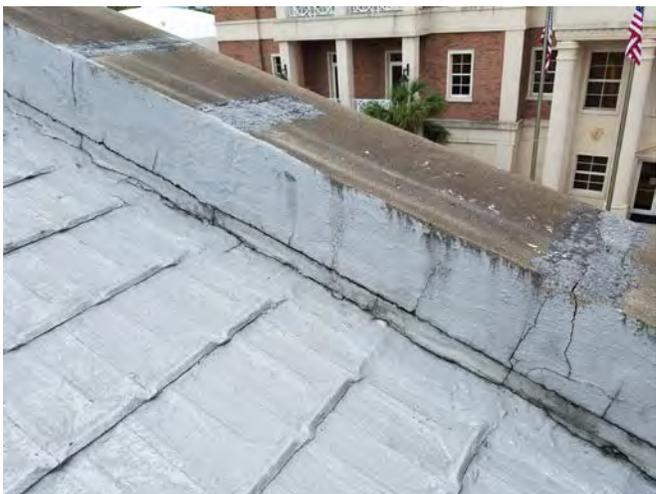
Detail photo of parapet wall at west end of roof. Note cracked mastic and damaged flashing.

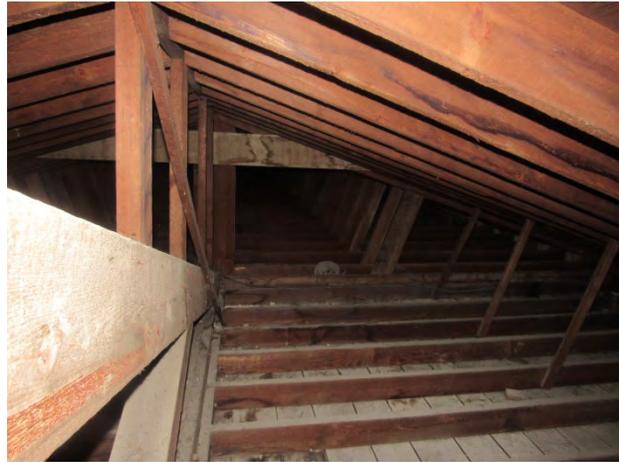
This view of the attic shows the 2x6 roof rafters and 2x6 ceiling framing. The rafters are in good condition.

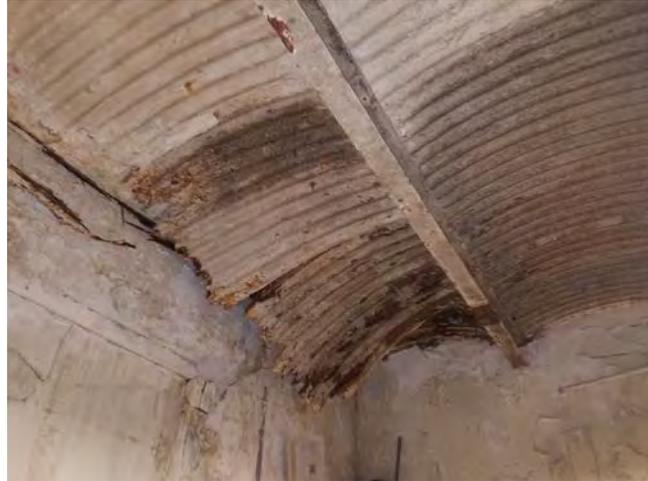
The second floor structure can be seen in this photo of the first floor ceiling. The structure consists of a framework of steel beams spanning concrete walls. Corrugated sheet steel is set between the beams, and used as formwork for a concrete slab. The corrugated sheet metal is rusted and falling away in some areas. The corrugated metal is no longer bearing any weight.

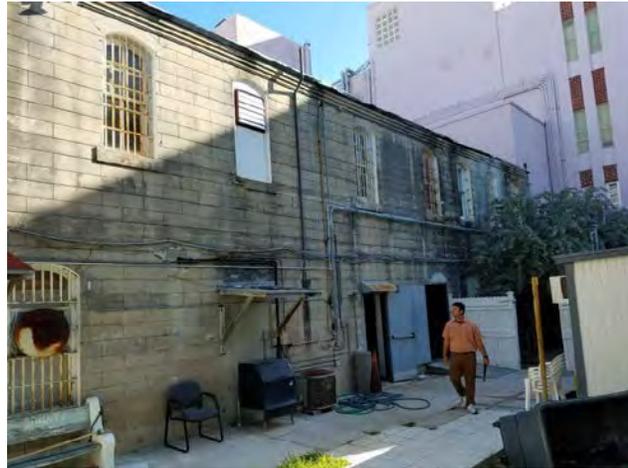
This partial view of the south façade of the jail building shows the joints tooled into the concrete walls, giving the appearance of block. Note the extensive amount of conduit and piping attached to the building. None of the miscellaneous roof overhangs are historic.

There is minor spalling damage at all of the exterior walls, evidenced by cracks and chipped concrete around window and door openings.

The exterior walls are in relatively good condition, with the exception of minor spalling. The spalling should be repaired as outlined in the structural portion of this report. In short, the damaged concrete and reinforcement is removed, new rebar is installed, the area is coated with new bonding agent, and new concrete is formed and poured. New joints should be tooled into the exterior concrete to match the historic joint pattern. Finally, all exterior cracks should be patched. Careful attention should be paid to match the historic concrete and stucco details. This will require attentive concrete work by a qualified concrete and stucco artisan.

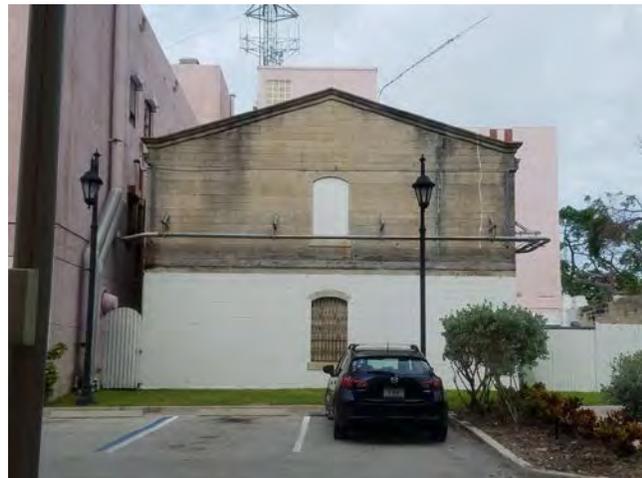
The west façade of the building is capped by a gable with a decorative cornice. Note the close proximity of the adjacent three story building to the north. This building is slated to be demolished.

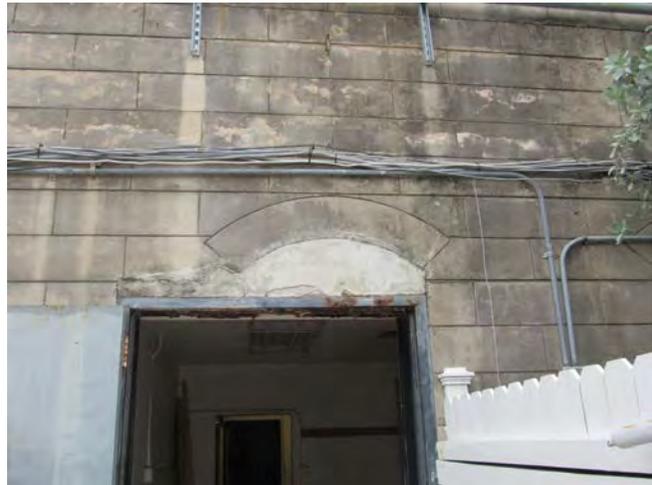
This painted metal door opening at the south façade was enlarged from a former window. The arch over the historic window can be seen above the door.

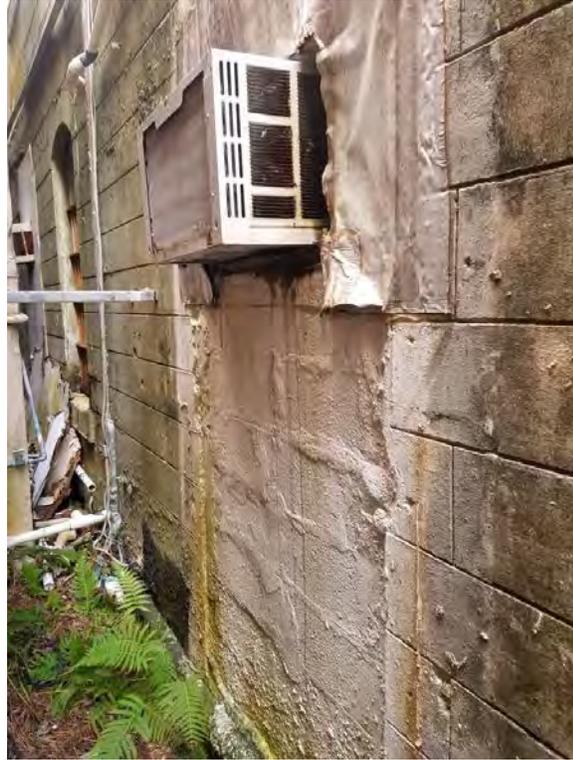
This painted metal door opening at the north side of the building has been enclosed with concrete.

The existing doors and openings should be removed, and new doors should be installed in their historic locations, including two on the north side of the building. Historic photos show the configuration of these doors and openings.

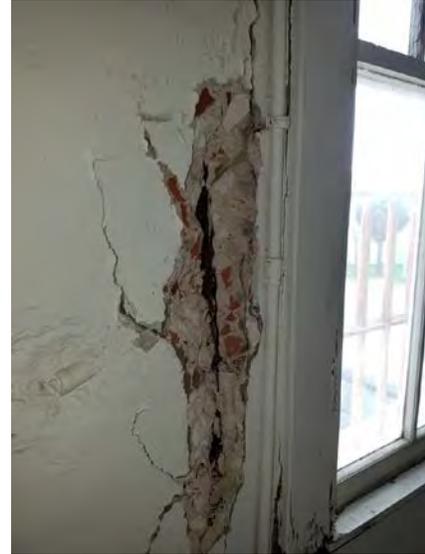
This interior photo shows spalled concrete around the perimeter of a typical window opening.

When design documents are developed, each of the window openings should be surveyed and recommendations should be included for each window. Vent fans, air conditioners, and plywood should be removed. The openings that have been sealed with wood or concrete should be reopened, and new wood windows and prison bars should be installed matching the historic units. Most of the metal prison bars are in restorable condition and should be patched, cleaned, primed and painted. Damaged double hung windows should be restored with appropriate wood window repair techniques. Spalling around historic window openings should be repaired. The spalling repair method has been covered in another section of this report.

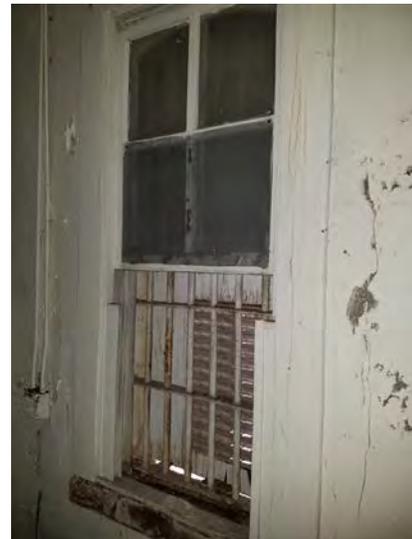
This interior view of a typical second floor window shows the painted wood double hung windows with bars at the exterior. This unit also has plywood over the exterior.

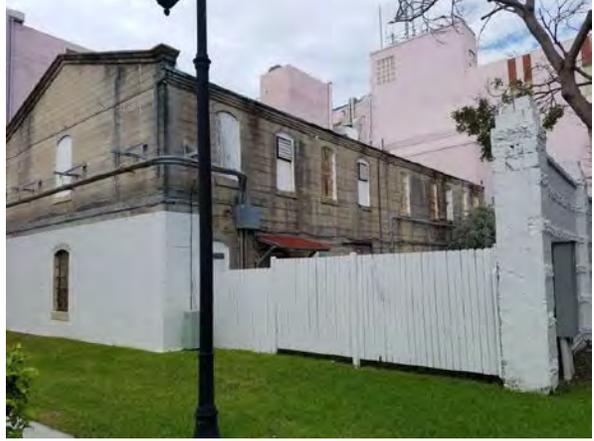
Currently, most of the historic windows at the jail have been altered in some manner. The prison bars have been cut and removed on a few of the window openings. Other windows have been entirely removed and the openings have been sealed with concrete or wood, such as those on the west facade. Many of the windows have also had vent fans or air conditioner units installed, surrounded by plywood. Doors have also been cut into several of the original window openings. Spalling has occurred on many of the window openings and sills, as a result of the rebar being set too closely to the concrete opening. The prison bars at many of the openings has also begin rusting as a result of deferred maintenance. The windows at the north side of the building have fared worse, as a result of the heavy moisture in the alley. These units are mostly removed or have been covered with deteriorating plywood. The prison bars are also heavily rusted on this façade due to moisture. One original painted wood double hung window with weighted sashes remains on the first floor. This window will serve as a pattern for replacement units.

This general view of the south and west sides of the building shows the varying condition of the window openings. Many have been removed, or covered with boards, or replaced with vents. Many are also intact behind plywood.

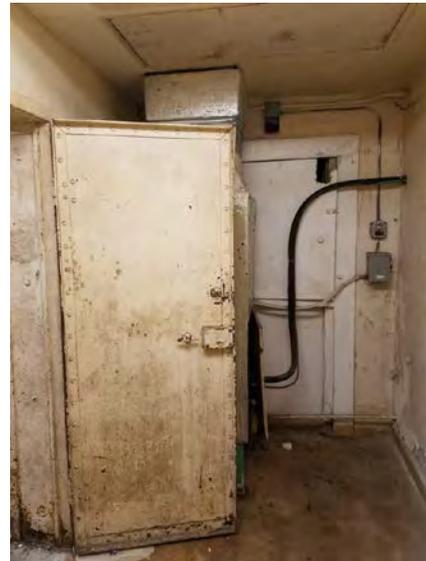
There is another historic cell door at the first floor, near the east side of the building. This is the oldest portion of the building, and this is probably the oldest original door in the building. This door consists of thick painted sheet metal with a frame of steel angle. This door is deteriorated but restorable.

This cell door at the first floor is one of the oldest doors in the building.

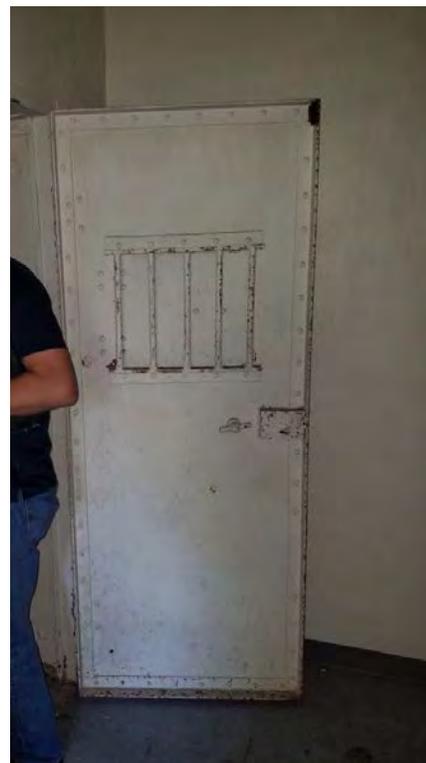
This historic cell door at the second floor leads to the large 6-unit cell block.

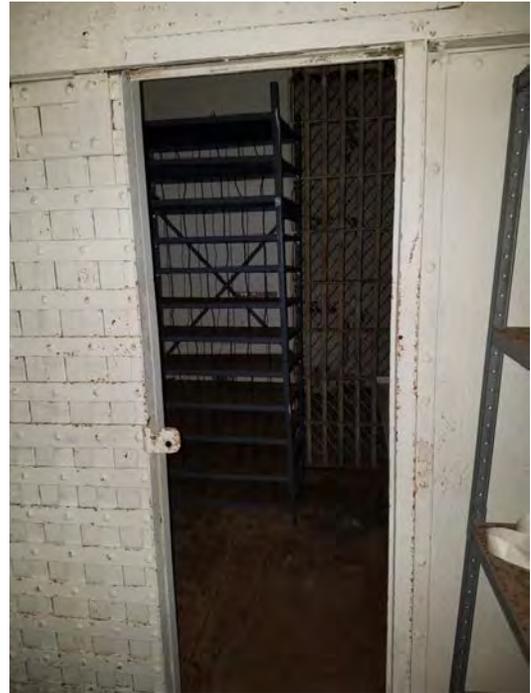
This is a typical cell door at the 6-unit cell block at the second floor. The doors, which consist of latticed metal, are all attached with mechanical linkages so they open simultaneously.

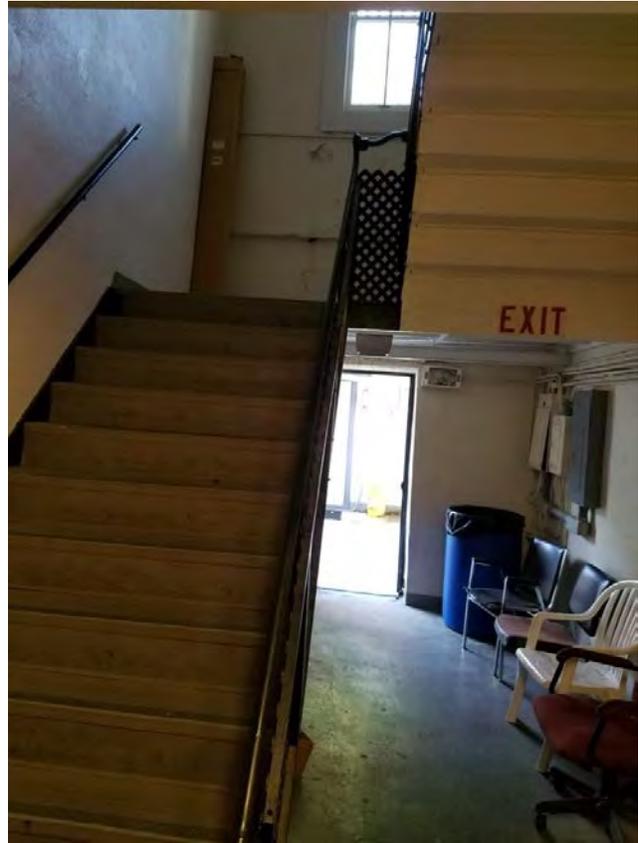
View of central stair from the first floor. The stair is composed of painted sheet metal. The landing floor is painted sheet metal. The guardrails are plastic lattice.

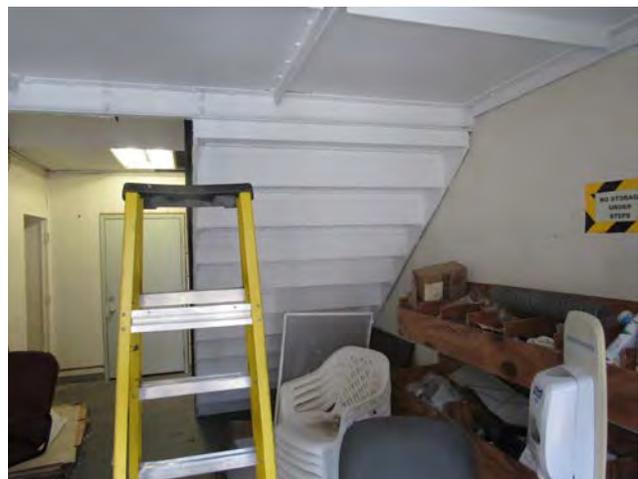
The underside of the stairs can be seen in this photo, as well as the structure of the landing, which is composed of steel angles and sheet metal.

The stairs should be cleaned, all deteriorated metal should be patched, and the stairs should be repainted.

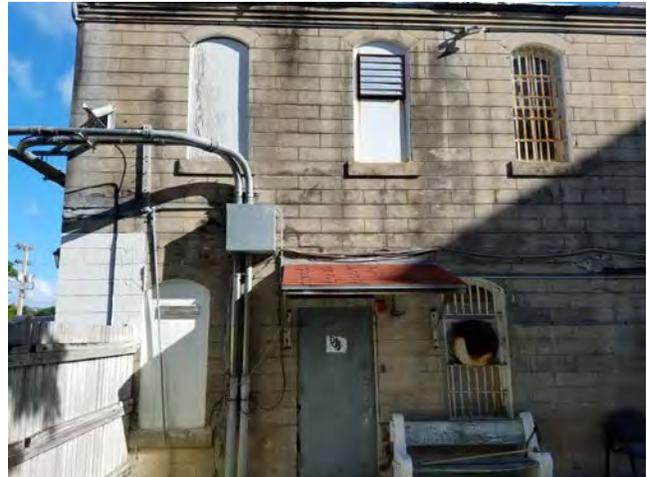
This partial view of the south façade shows one of the contemporary roof overhangs. Note the large amount of conduit, piping, wiring and other equipment attached to the building.

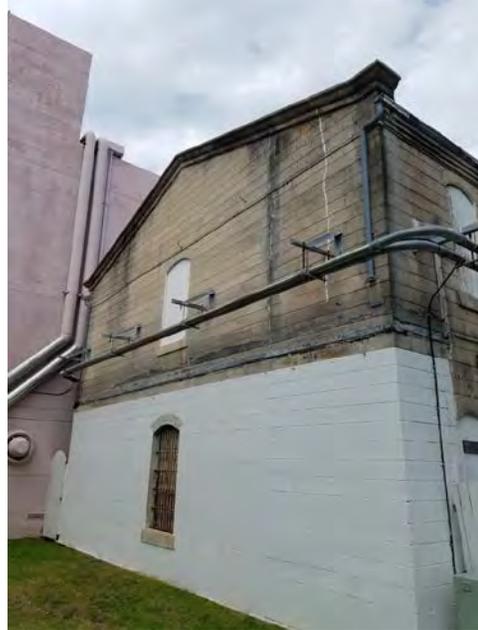
This view of the west façade shows the detailing of the gable end at the top of the roof, as well as the stepped cornice at the south side of the building.

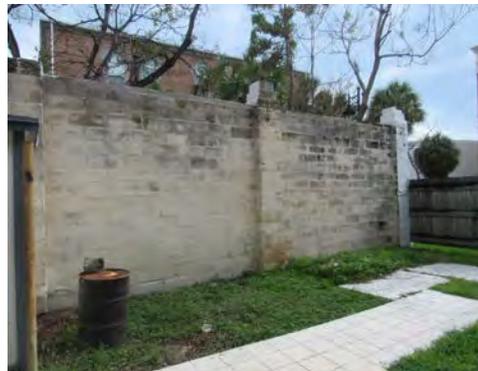
General view of the prison wall. The wall dates to circa 1907.

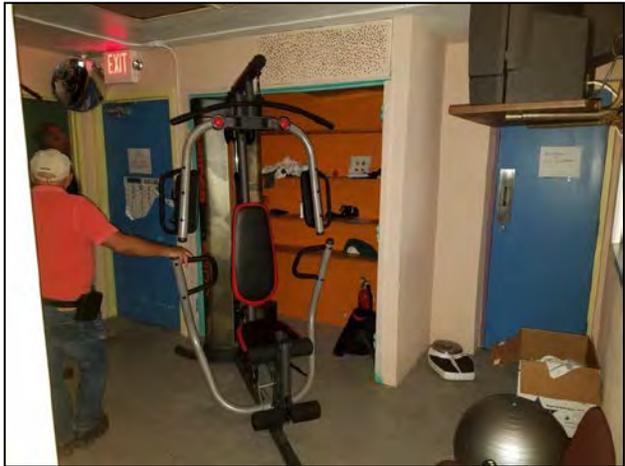
General view of gym at the first floor, west side of the building.

First floor, west side: This area originally contained prison cells, and is currently used as a gym. The area is divided into small cells, many windowless. The floors are composed of vinyl tile, the walls are painted plaster, and the ceilings are painted plaster. All of the finishes are extremely worn. The ceiling height in this area is approximately 95". This area also contains a restroom area with showers. The finishes and fixtures in this restroom are extremely worn.

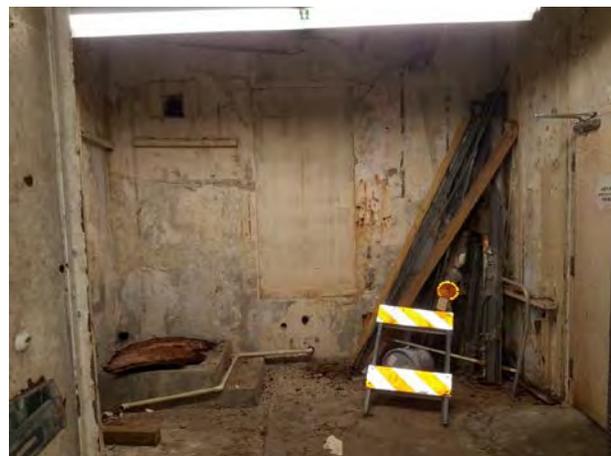
First floor, east side: The east side of the building is older, with some portions dating back to original construction. The finishes in these areas are extremely worn. Floors are concrete, the painted walls are peeling and deteriorated, and the ceilings are a combination of painted plaster and the corrugated steel formwork for the second floor above, with painted steel beams in between. This steel is extremely rusted where it is exposed. The walls are covered with exposed conduit, ductwork, and equipment. Various rooms in this area are still used for storage and office space, and are still conditioned by wall mounted units.

Typical finishes at the first floor, east side of the building include plaster walls and concrete floors.

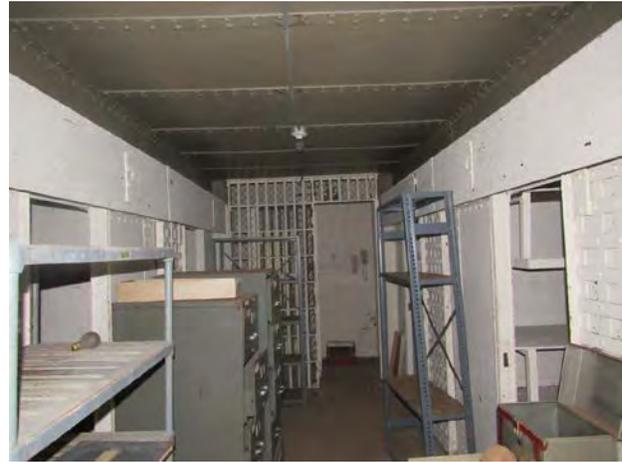
General view of 6-unit freestanding cellblock at the second floor, west side. The cellblock is currently used for records storage.

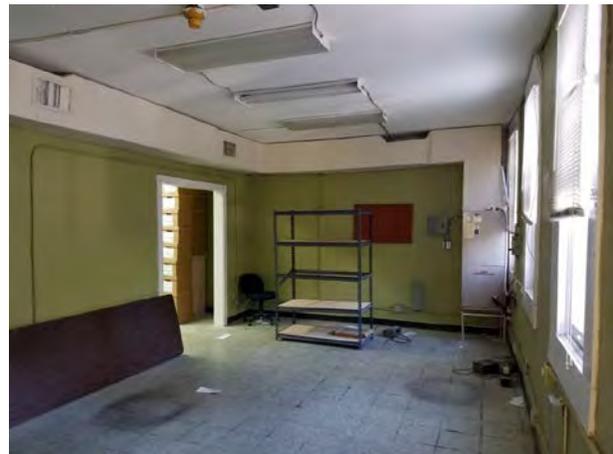
General view of the second floor east side. Finishes include vinyl tile, plaster walls and plaster ceilings.

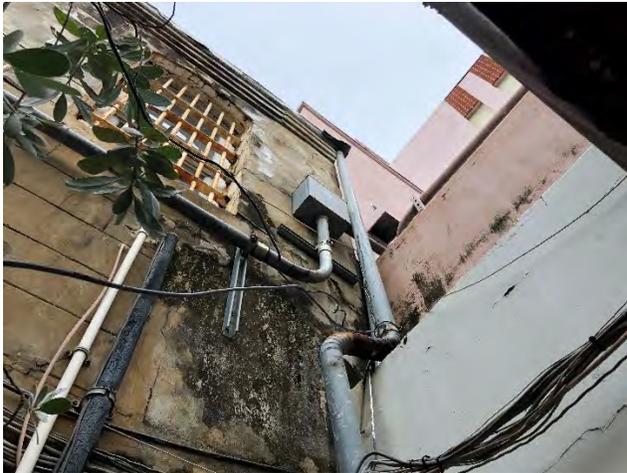
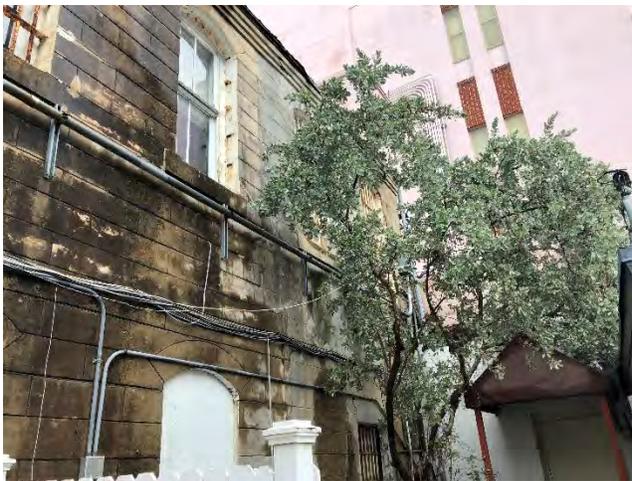
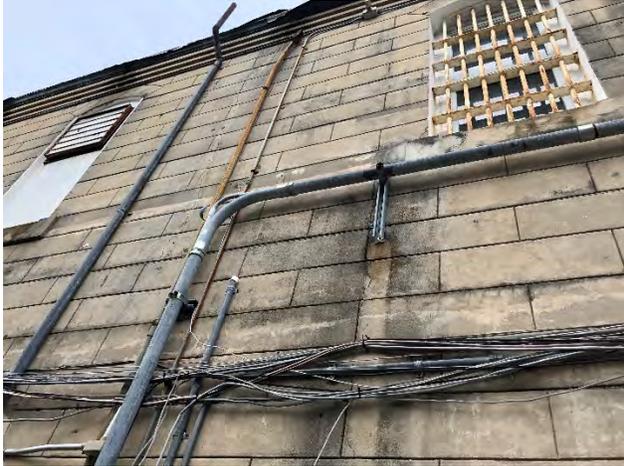
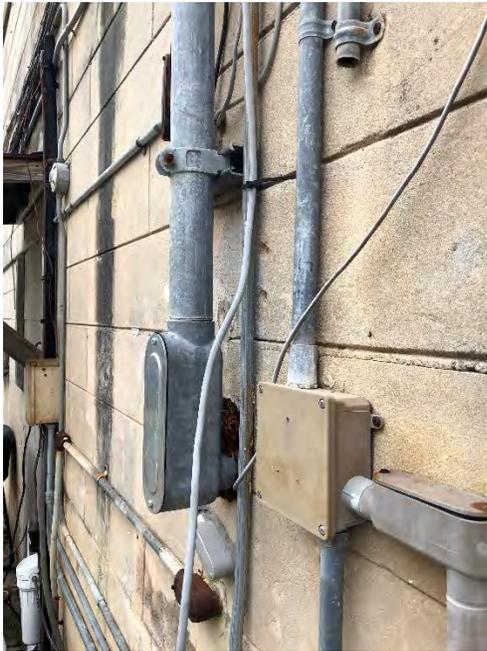
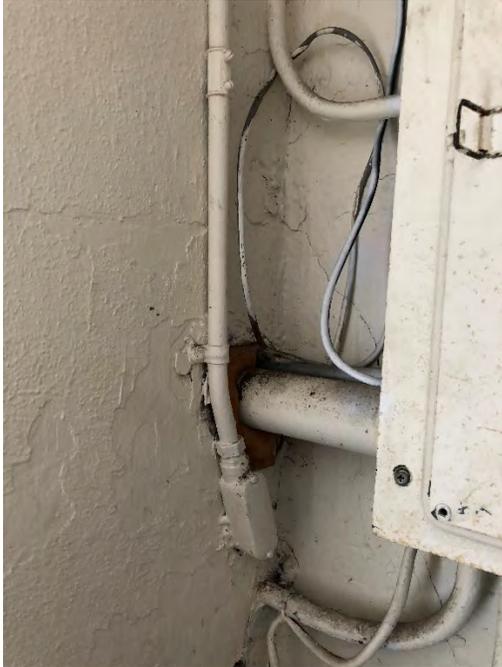
The existing electrical system is connected to the Keys Energy pad mounted transformers located at the rear of the building. Main disconnect switch is currently located in an electrical room inside the existing 5 story building and was not located at the moment of the visit due to lack of labeling on the panels. Following pictures show conduit routing on the side wall and penetration to main termination point.

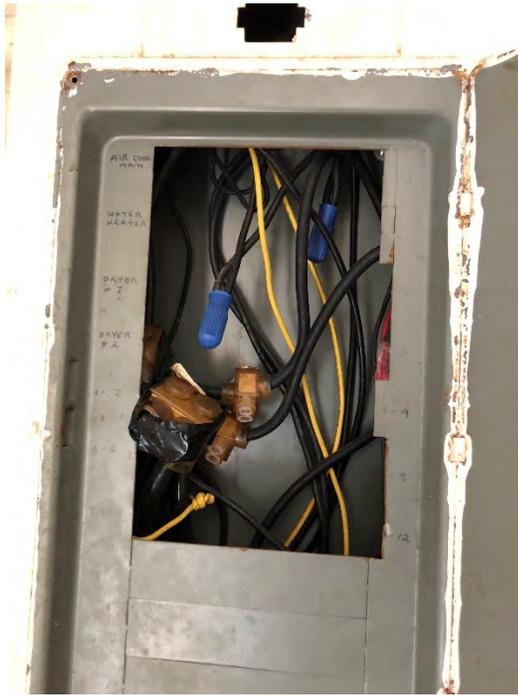
Existing electrical service entry point (electrical panel) does not have any safe means of disconnection or power isolation, only splices to feeders and branch circuits. Refer to picture.

It is recommended to completely replace the existing electrical power system with new power layout and service connection as well as to have a dedicated service meter for this building.

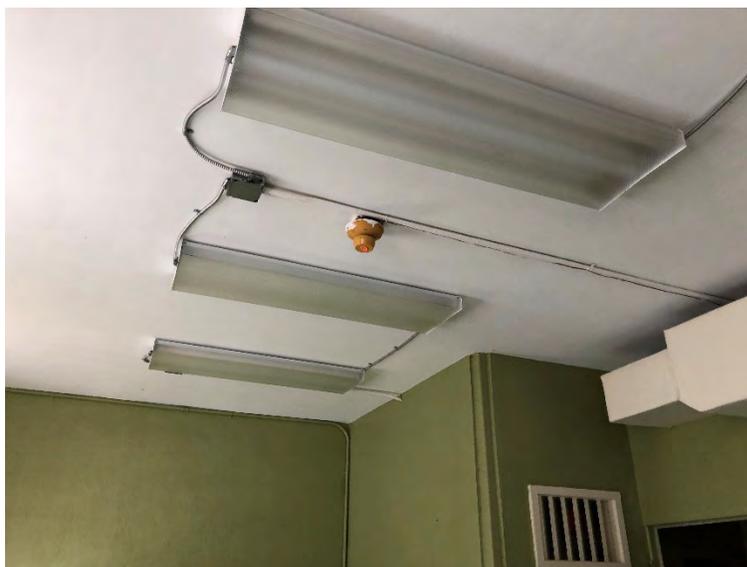
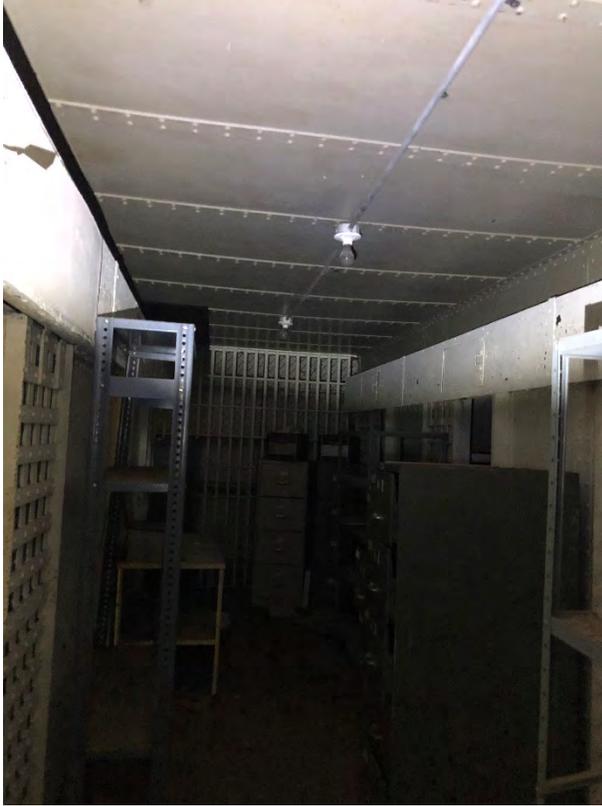
Existing lighting system is outdated with fluorescent T40 lamps fixtures and incandescent keyless socket fixtures and will require replacement. Coordinate with architect new lighting fixture type and placement in order to maintain original building structure and purpose.
