MONROE COUNTY HISTORIC JAIL

HISTORIC STRUCTURES REPORT

January 2018

By: *Bender & Associates Architects p.a.*
410 Angela Street
Key West, Florida 33040

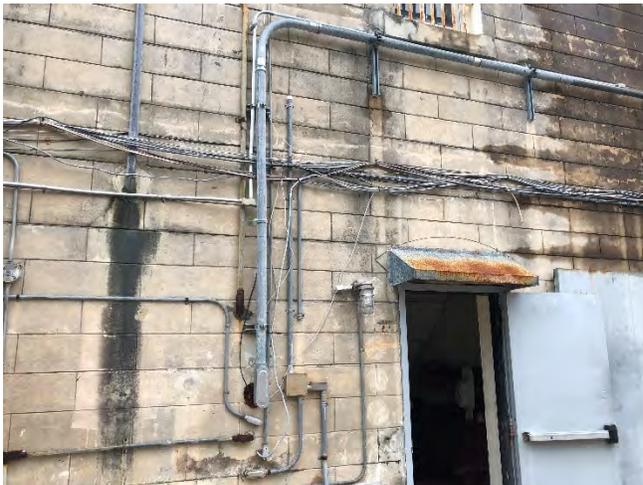
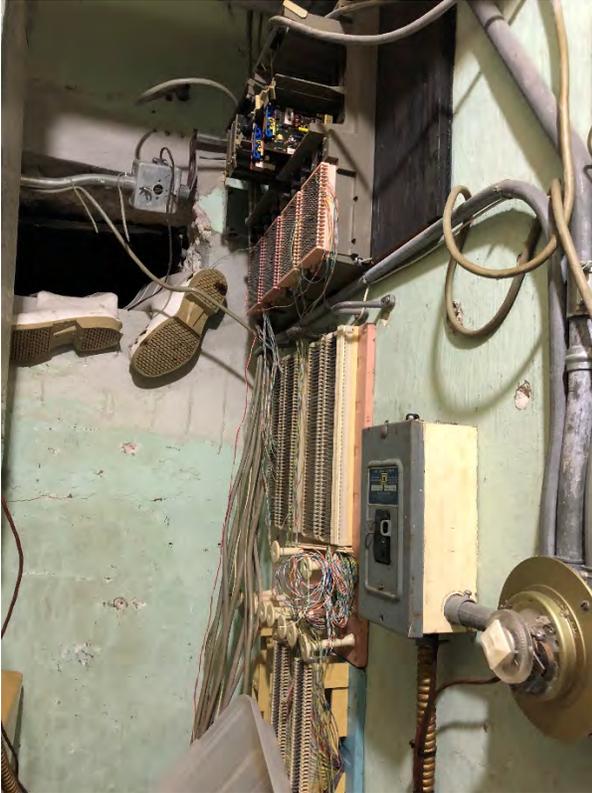
The existing telephone system will need to replace existing telephone lines with new wiring. Existing telephone service is located on the west side of the building. Telephone and data lines currently running on side wall to be removed. Existing telephone backboard/data equipment to be relocated from present location due to lack of clearance (A/C unit blocking access). Refer to pictures.

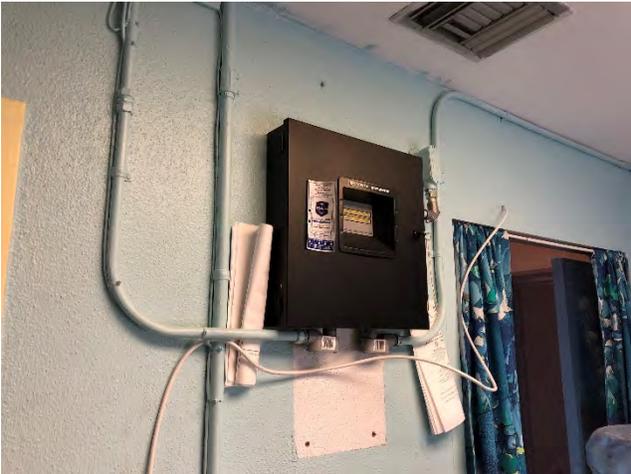
All A/C equipment disconnect means are to be replaced due to excessive corrosion.

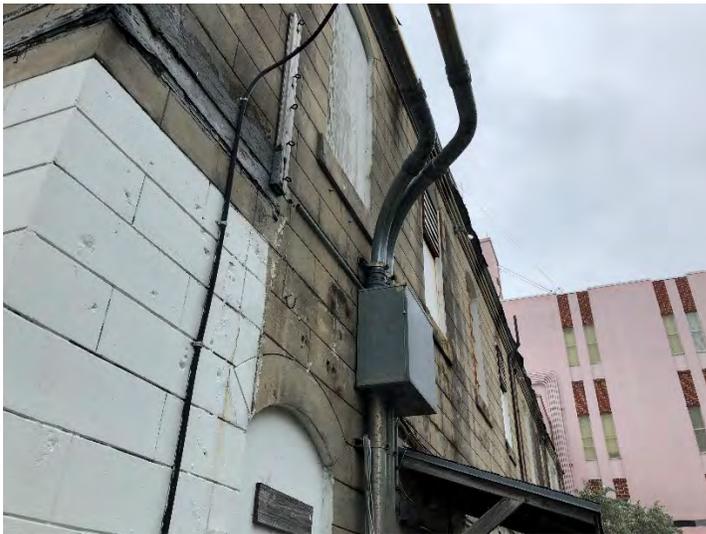
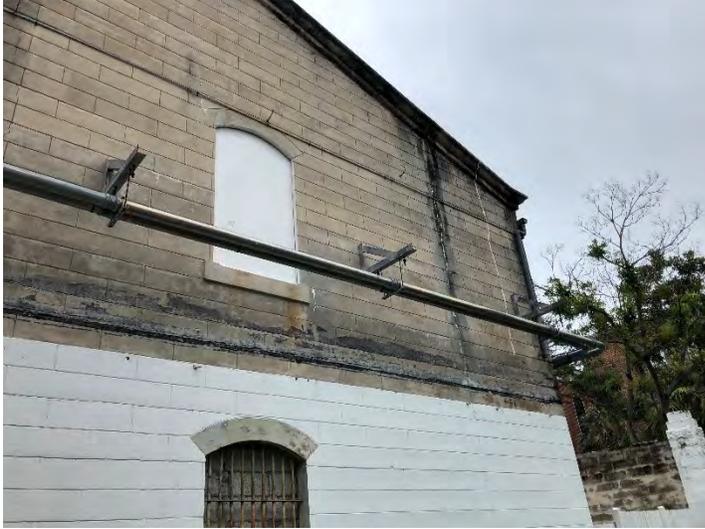
Existing emergency generator located on the roof of the 5 story building does not provide back-up power to the existing jail building. It is being used as a back-up power for existing chiller plant located also on roof. Existing chiller plant electrical feeders currently running on south and west wall of building to be relocated in order to restore original building façade. Refer to pictures.

It is recommended to replace the entire electrical power, lighting & fire alarm system with new equipment due to the unsafe and non-code compliant system currently installed. Location and labeling of existing main disconnect switch in existing building shall be priority. All existing electrical panel shall be removed and replaced. New location as per architect's recommendations in order to maintain building original purpose. New service point connection to power company and telephone company shall be established as well as an independent electric meter.

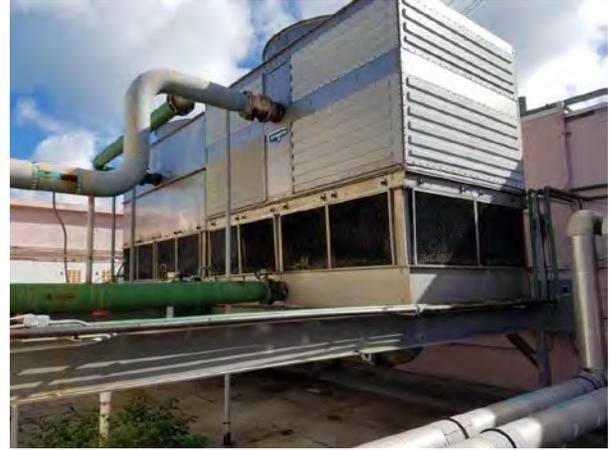
The historic jail building complex is served with multiple type air conditioning systems. There is a centralized chilled water plant and cooling towers in the new portion of the building complex. Chilled water is distributed to multiple buildings with using a centralized underground chilled water loop that serves multiple buildings. None of the air conditioning systems in the original historic building is served with chilled water air conditioning systems.

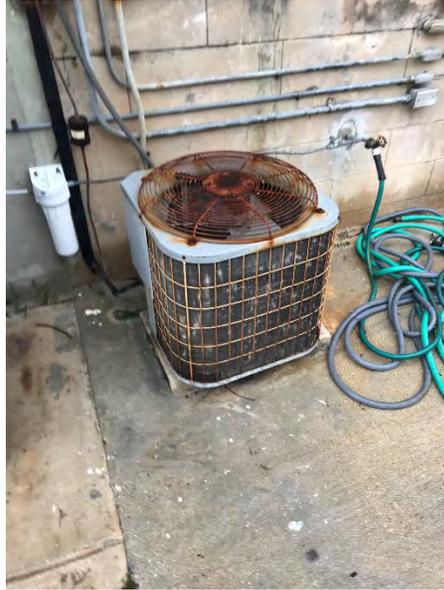
There is a portion of the building provided with only mechanical ventilation. Fans have been installed behind windows and don't seem to be operational.

Existing Window mounted fan

Existing Condensing Unit

The historic portion of this building was not designed to be an air conditioned facility. Retrofitting this building to be compliant with current standards will require complete demolition of all existing outdated or inadequate air conditioning systems, ductwork and distribution devices. The introduction of air conditioning and mechanical ventilation to this facility will require careful consideration of existing historic building elements.

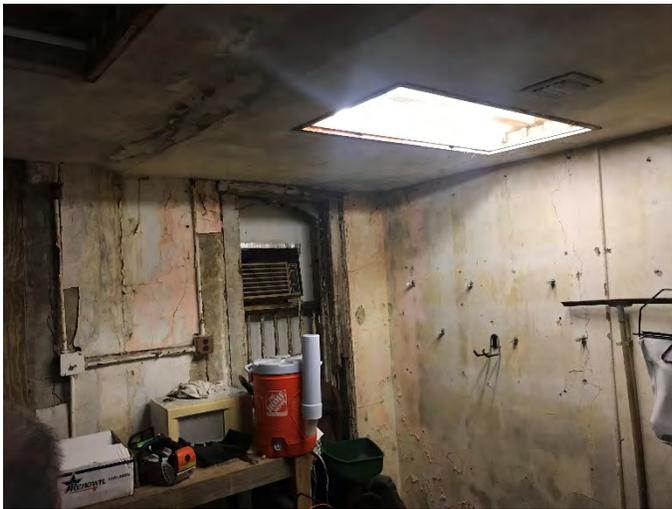
Wall Mounted Air Conditioning Unit

All of the components and mechanical systems are beyond their useful life or inadequate for the type of building and its particular historic characteristics.

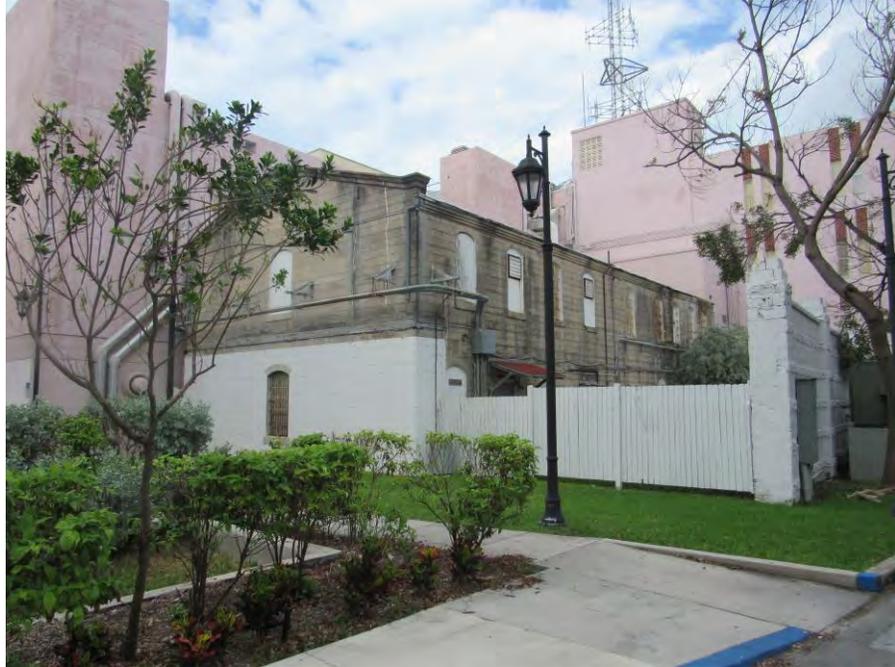
PHOTOGRAPH 1

The Monroe County Historic Jail is the two-story cellblock remnant of the 1892 Monroe County Jail, and the 1910 two-story cellblock addition (see Photograph 1). The administrative front wing of the jail was demolished in 1952. Construction consists of a wood framed, gable roof with metal shingle roofing on 7/8" x 6-3/4" wood sheathing, on 2" x 6" wood rafters at 16" on center, supported by a ridge heavy timber truss spanning between transverse load bearing walls and the perimeter walls (see Photographs 2 and 3). Supporting the second floor ceiling is 2" x 6" wood joists at 16" on center with a ceiling below consisting of plaster on 1" x 4" tongue and groove sheathing, or the 1" x 4" tongue and groove sheathing on 2 x sleepers on corrugated metal deck on 1" x 8" sheathing on the ceiling joists (see Photograph 4). The second floor consists of an arched corrugated steel formed concrete slab supported by steel beams at 3'-0" on center, spanning between the gable walls and the interior walls (see Photograph 5). The ground floor is a concrete slab on grade and the load bearing walls of the 1892 cellblock remnant, and the 1910 cellblock addition are constructed of the revolutionary fireproof material, reinforced concrete with a brick cornice at the roof, of which the roof rafters and ceiling joists are fire cut into. Founding the 1892 cellblock remnant and the 1910 cellblock addition load bearing walls are concrete footings socketed into the caprock. Access between the first floor and second floor is by a central steel framed stair with a concrete filled landing and concrete filled treads. South of the historic jail is a portion of the CMU prison yard wall, also founded on concrete footings socketed into the caprock.

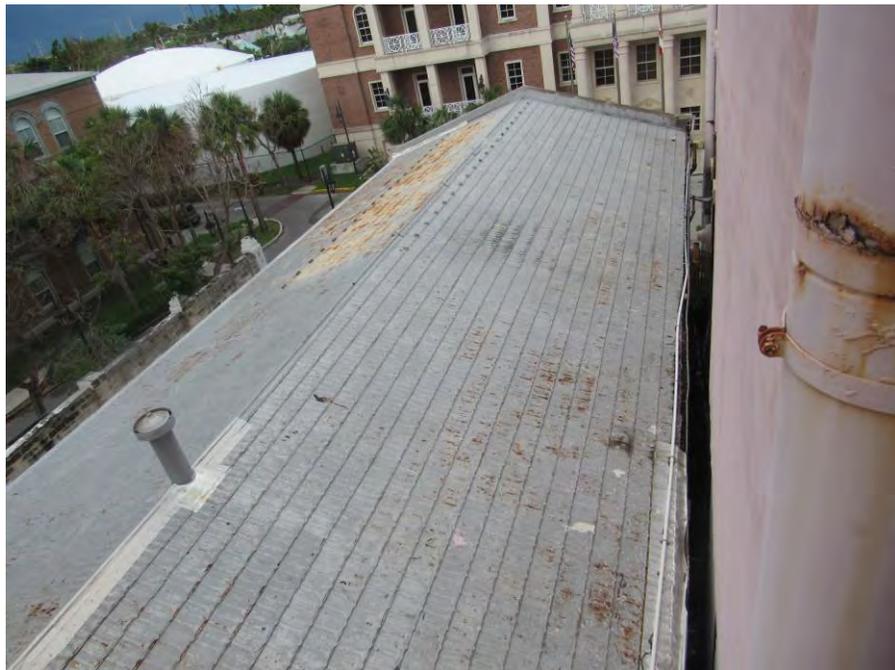
PHOTOGRAPH 6

The metal roofing is in poor condition with numerous patched areas. In contrast, the roof and second floor ceiling framing appear in excellent condition, as well as, the roof sheathing that could be observed (see Photographs 6 and 7). The roof has experienced leaks in the past, so there are probably areas of roof sheathing deterioration. There does not appear to be any mechanical anchorage of the roof rafters and second floor ceiling joists to the brick cornice and supporting concrete walls. The majority of the second floor is in excellent condition except in the eastern storage room where the corrugated steel forms are corroded, as well as, their steel beams and several floor cracks in the cell block floor, where the steel floor beams below are corroding and exfoliating creating cracks and spalling in the concrete floor (see Photographs 8 and 9). At the top of the stairs, the original steel bar construction is still intact under the wall finishes and the steel framed stair is in excellent condition except for a badly corroded intermediate landing channel at the exterior wall (see Photographs 10 and 11). At the floor of the stair exterior wall, the steel "I" beam in the wall has surficial corrosion (see Photograph 12). The exterior concrete walls are in good condition, but they do have numerous cracks, spalled areas and exposed corroding reinforcing (see Photographs 13, 14 and 15). The reinforcing is twisted square steel bars, which is a type of reinforcing used in early reinforced concrete buildings. At the second floor restroom window, the wood jambs embedded in the concrete are badly deteriorated and this condition probably exists elsewhere (see Photograph 16). The CMU prison yard wall is in excellent condition except for two (2) areas of stair stepped, cracking; two (2) vertical wall cracks, and an area of vegetation growing in the masonry joints (see Photographs 17). The stair stepped, joints and vertical wall cracks appear old and could be the result of old settlement. There are no signs of settlement in the cellblock building.

The Monroe County Historic Jail is in good condition, but it does require repair. The metal roofing is in poor condition and when it is replaced, the roof sheathing should be removed at the roof rafter bearing at the perimeter wall so that they can be mechanically anchored to the exterior bearing concrete walls. The corroded second floor, corrugated steel forms and steel beams need to be cleaned of corrosion and painted, as well as, the stair floor beam. The badly corroded intermediate stair landing channel will require replacement. There are numerous cracks, spalled areas and exposed corroded reinforcing in the concrete walls. The spalled areas and areas of exposed corroded reinforcing need to have the deteriorated concrete removed back to sound concrete in square cuts. The reinforcing needs to be coated with a corrosion inhibiting bonding agent and the areas filled with concrete repair mortar. At the cell block where the floor is cracking and spalling due to corrosion of the second floor beams below, the deteriorated concrete needs to be removed back to sound concrete in square cuts. The steel beams and reinforcing needs to be coated with a corrosion inhibiting bonding agent and the areas filled with concrete repair mortar. The wall cracks should be filled with epoxy and the deteriorated embedded wood in the walls removed.

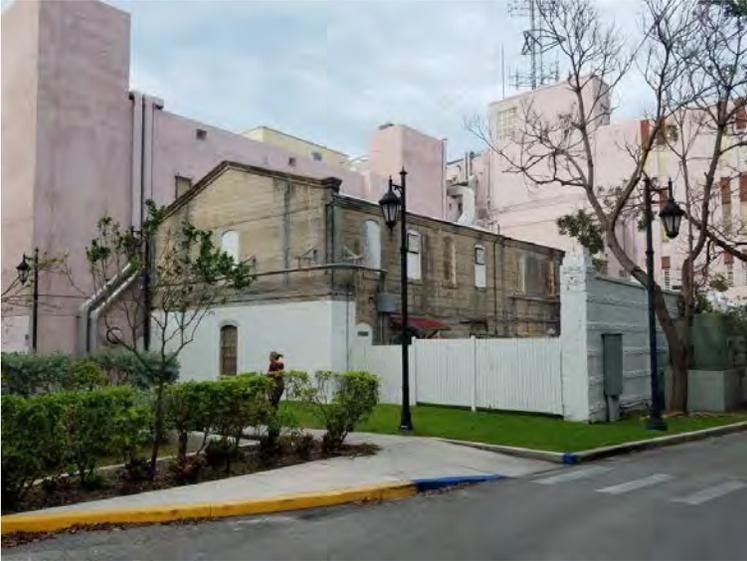
This general view of the rear of the historic jail shows the clearest view of the building. The building, which once faced Whitehead Street, is now located behind the five-story Courthouse building seen at right. To the north of the jail lies a three story office building constructed in the 1980s. This building lies only 40 inches away from the historic jail. Both these buildings are slated for demolition. Note the remains of the historic prison wall at right.

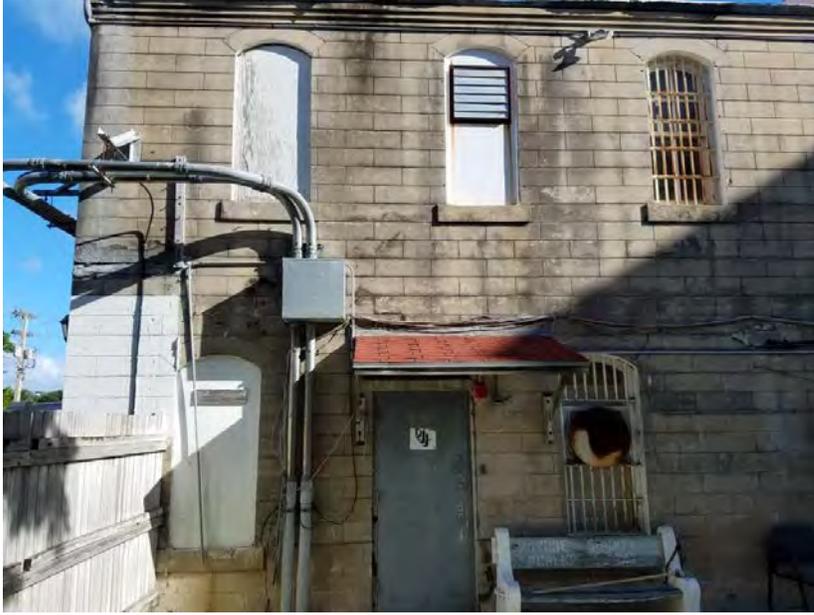
This partial view of the south side façade shows the general condition of the building’s exterior. The façade is composed of poured concrete. Tooled joints in the concrete give the perception of 8” x 24” concrete block. The top of the wall features a simple stepped-out cornice. The regular rhythm of window openings has been severely altered by the insertion of doors and the blocking-up of windows with concrete or wood. The façade is littered with piping, conduit, wiring, and brackets.

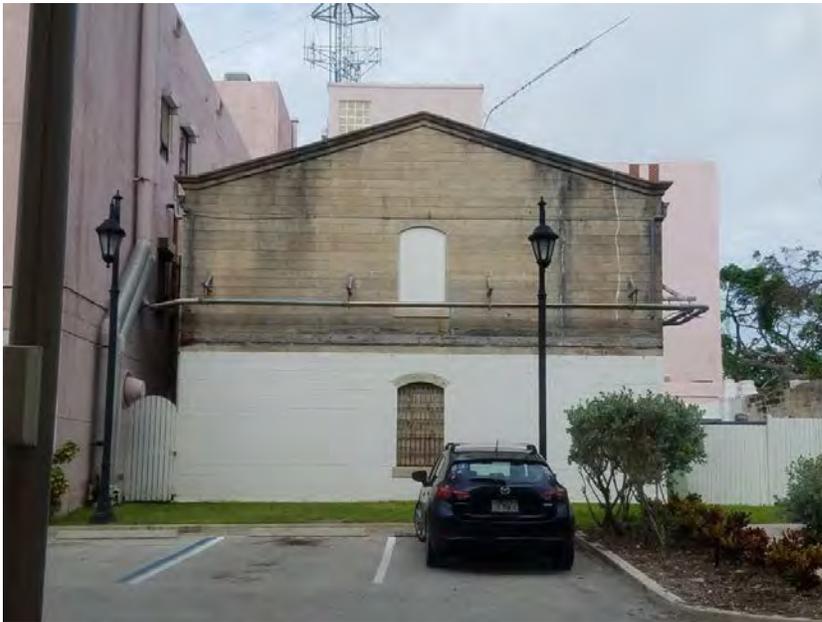
The rear (west) façade is the most clearly visible. This façade features the same tooled concrete block joints, along with an elegant stucco cornice at the gable. This façade, which faces a parking lot, is also covered with miscellaneous wiring, brackets and piping.

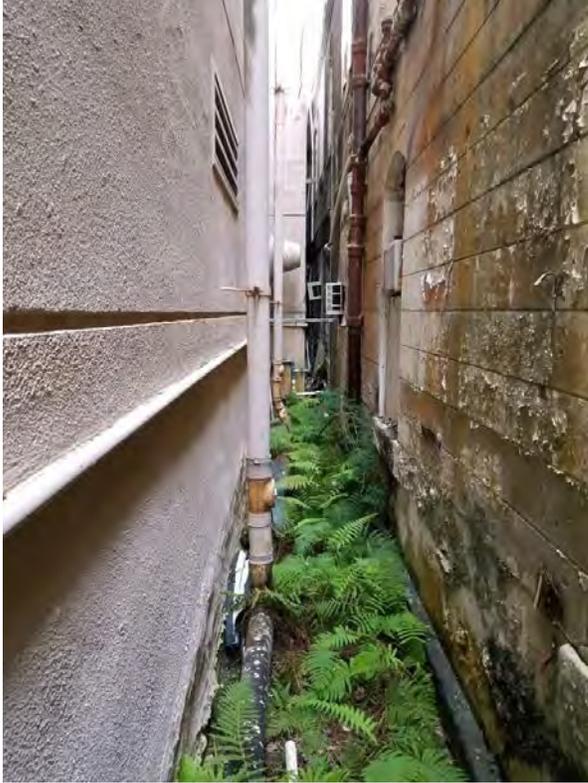
The north façade of the building is a mere 40” from an adjacent office building built in the 1980s. This façade features the same rhythm of windows as the south façade. Most of these windows are either covered with plywood or concrete. Inadequate drainage from the roof has created a moisture problem in this alley that is damaging the building. Note the peeling paint and organic growth.

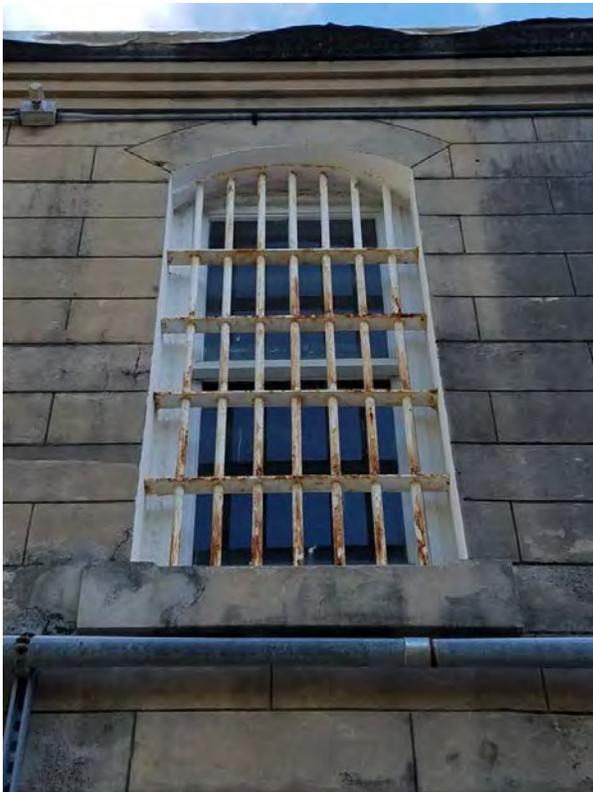
This photo shows a typical historic window. Painted prison bars were set at the exterior behind a painted wood double hung window. The window opening has a gentle arch, which is accentuated by tooled lines in the concrete wall simulating a curved header. Each window also features an elegant stucco sill which protrudes approximately 1.5” from the face of the façade. The stepped cornice can be seen above this second story window. Note the piping and conduit covering the building.

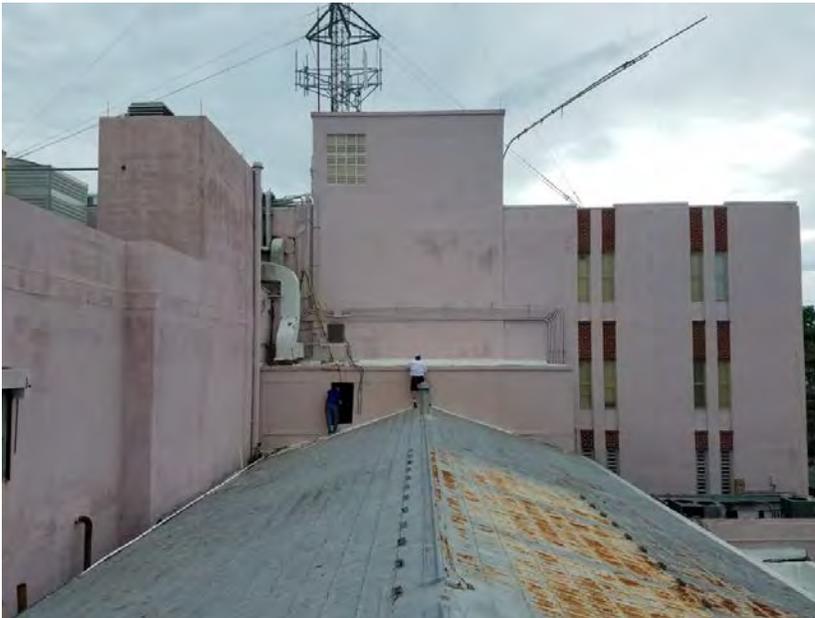
This general view of the roof shows awkward attachment of the historic building to the newer 1965 courthouse. The simple gable roof of the jail is composed of metal shingles. The shingles are rusted and deteriorating and require replacement. Several rows of brackets can be seen along the roof ridge. These are probably the remains of a roof-mounted solar heating system. Note the proximity of the office building at left, creating a 40" wide alley.

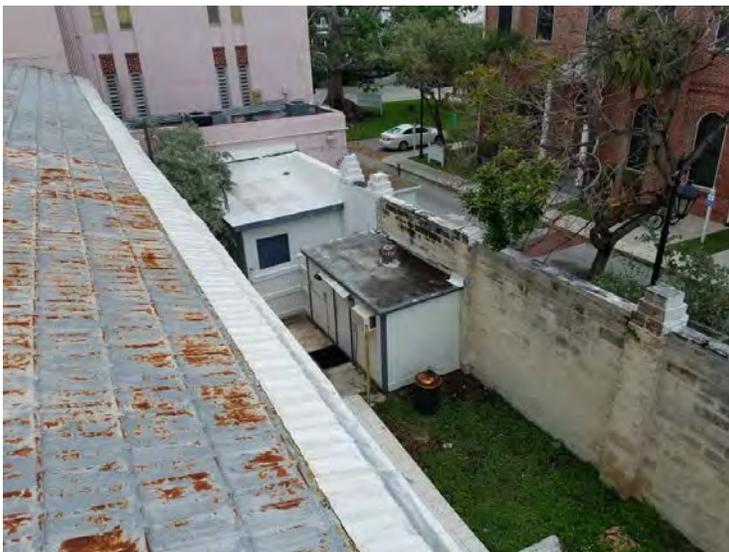
This view from the south edge of the roof looks down at the courtyard formed by the historic prison wall. Several small outbuildings are located in this courtyard. Note the damaged roof edge; a patch has been installed over the ogee gutter to stop leaking. The 1891 historic Monroe County Courthouse can be seen at right. The front of the jail building, now removed, once proudly faced Whitehead Street next to the 1891 Courthouse.

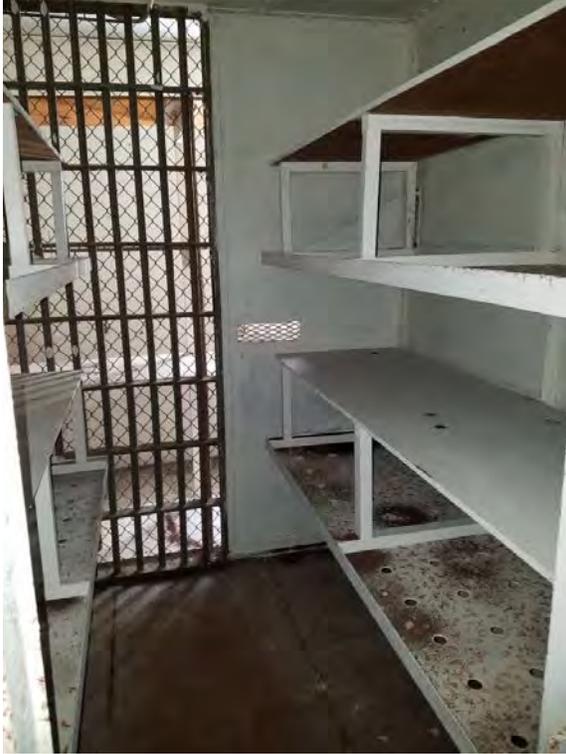
The jail still contains a large 6-unit cellblock at the second floor. This cellblock, made of painted metal, is independent from the structure of the building, and has its own floor, walls, and roof. This is one of the most significant characteristics of the historic building. The cellblocks are currently used for records storage.

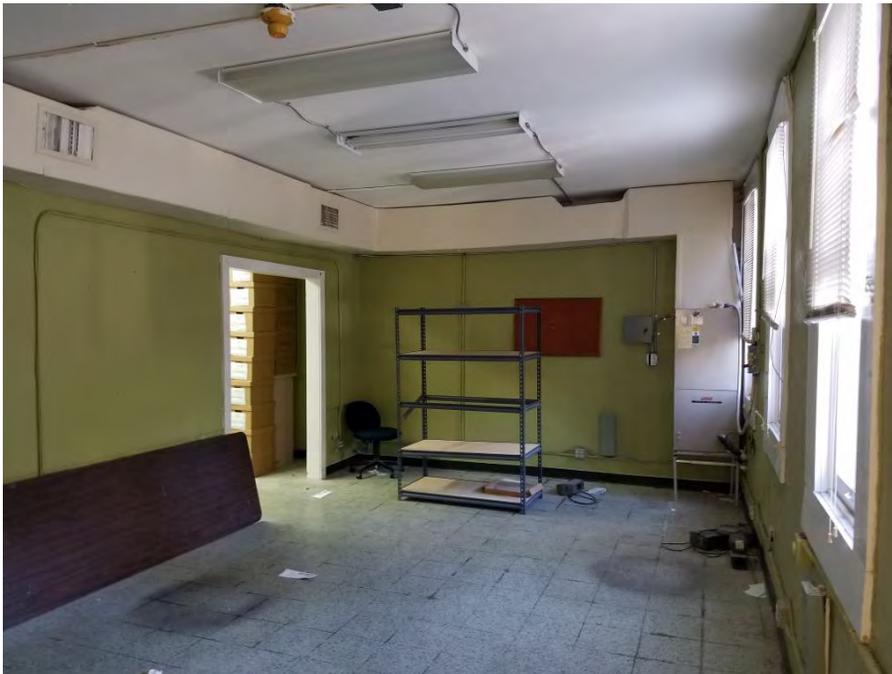
This is a typical room at the second floor, east side. The area is used for storage, and is composed of vinyl tile, plaster walls, and a plaster ceiling. Note the air handler and ductwork at far corner of the room. The room is covered with surface mounted conduit and ductwork. Most of the walls are concrete and there is nowhere to run wiring. All of the finished in the building are badly worn.

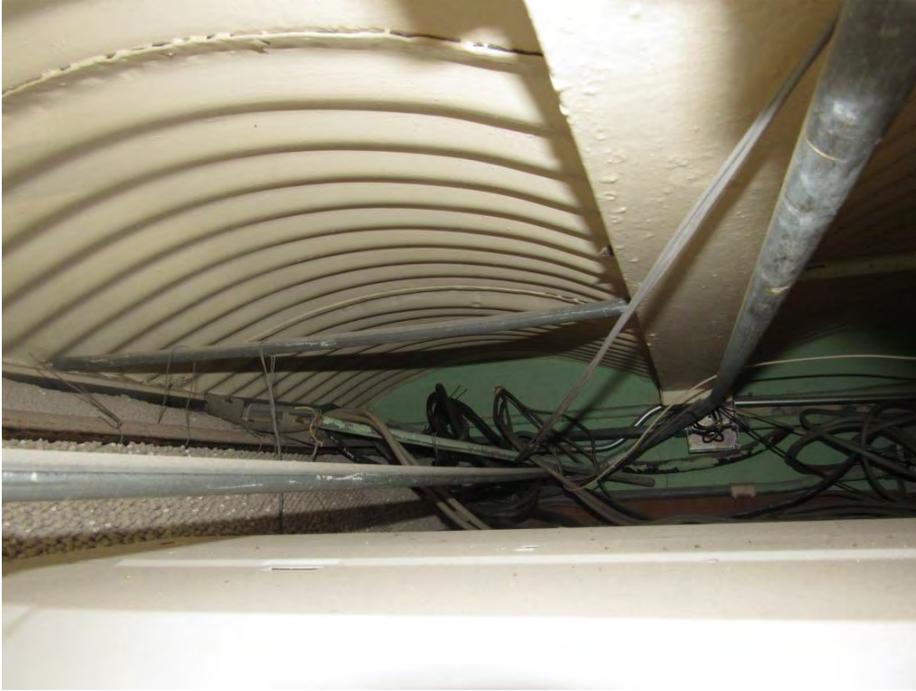
This view of the first floor ceiling shows the construction of the second floor. Corrugated sheet steel is set in arches between a grid of small steel beams. The corrugated steel served as formwork for a layer of poured reinforced concrete above. Finally, a plaster ceiling was installed below the assembly.

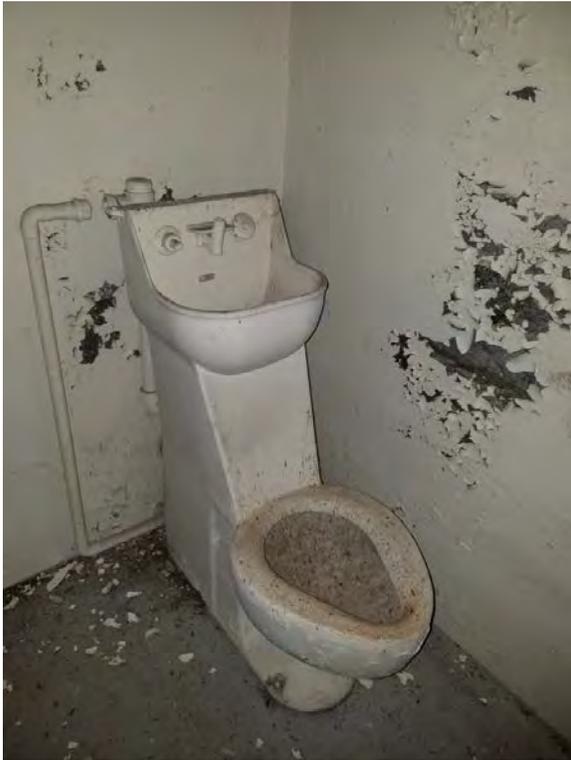
A group of former cells at the first floor has been converted to a gym. Finishes include vinyl flooring, painted plaster walls and painted plaster ceilings.

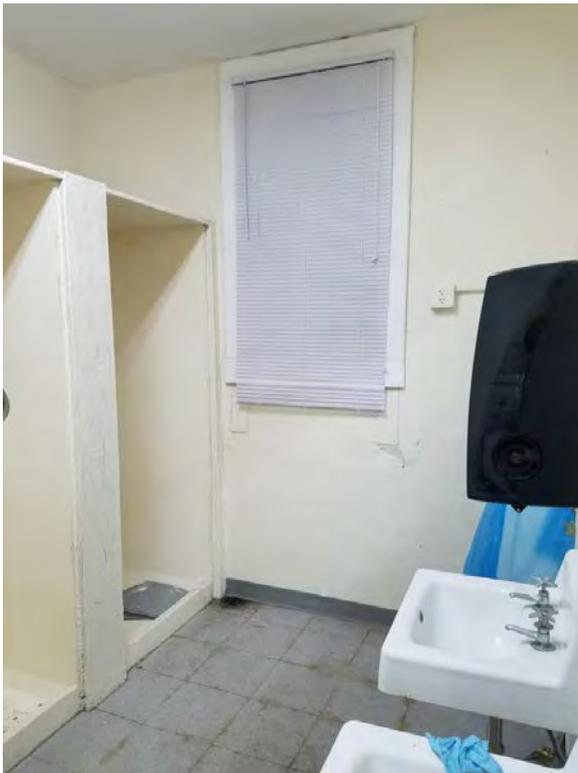
This restroom is located at the second floor, near the center of the building. The restroom features sinks, WC's and showers. Both fixtures and finishes are badly worn and non-functional.

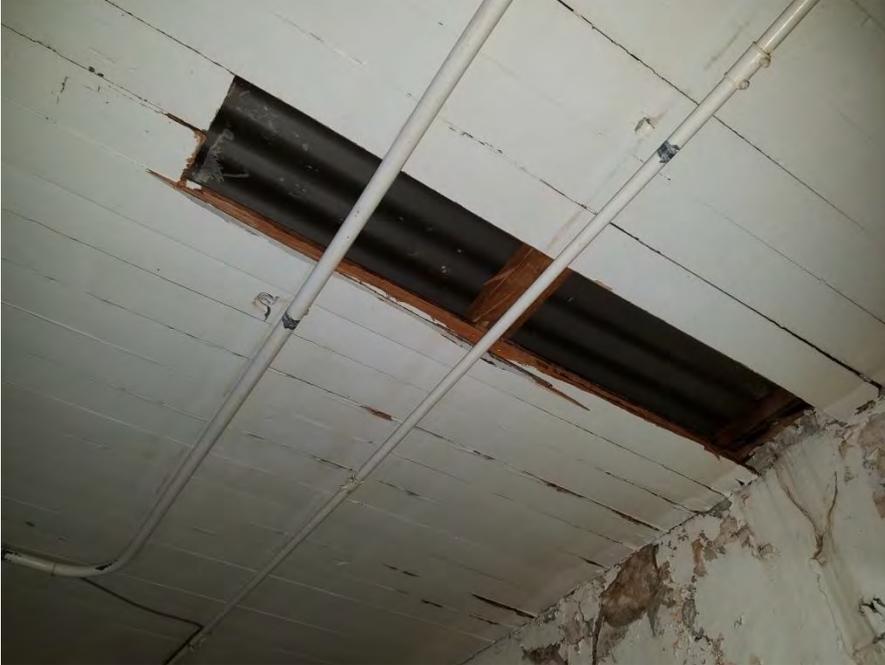
This view shows the ceiling of the second floor. The construction is unique; a layer of corrugated steel was installed over the wood ceiling joists, followed by furring over a painted wood T&G finish ceiling. The corrugated steel, which is visible in the photo above, prevented access to the attic.

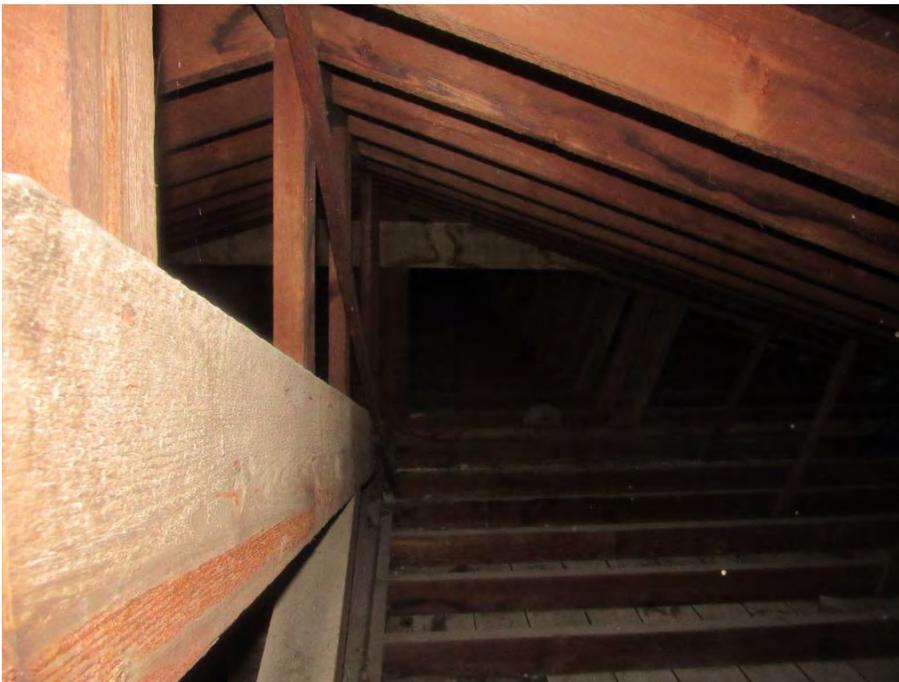
The only access to the building's attic is through the adjacent courthouse building. The roof framing, composed of full 2x6s at 16" o.c., is in good condition. The ceiling joists, also full 2x6s, can be seen at bottom.

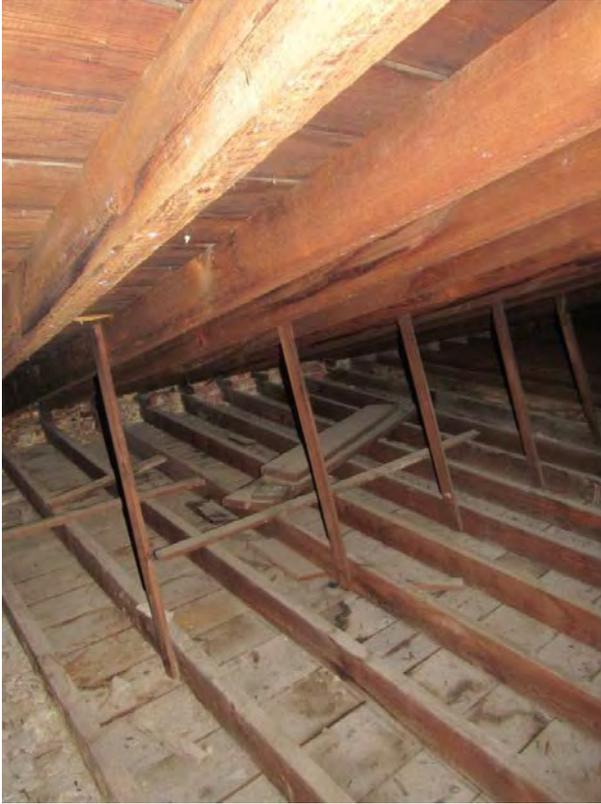
This view of the attic shows the rafters and ceiling joists connecting to the top of the exterior wall. The wood roof sheathing can be seen between the joists.

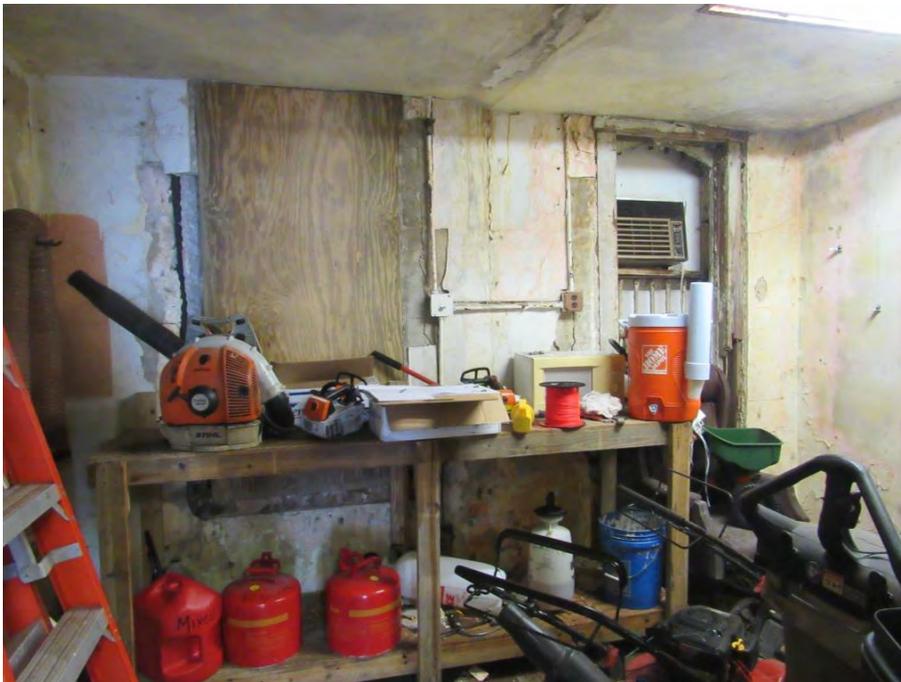
View of a storage room at the first floor. Note the spalling around the window opening, which is covered with plywood.

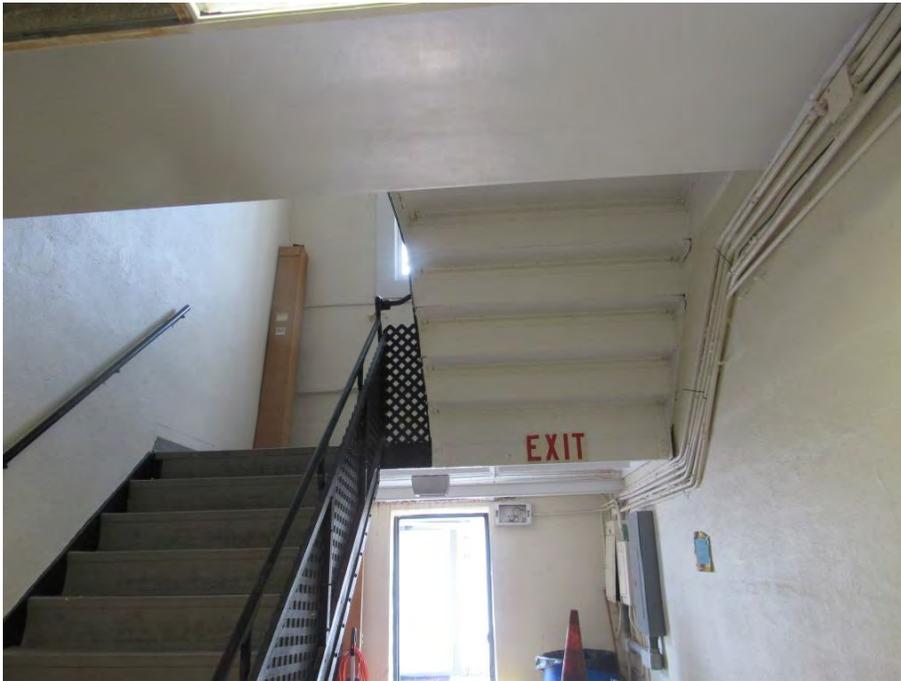
The only stair is located near the center of the building. The stair is constructed of painted sheet metal and painted steel framing. The guardrails have been reinforced with plastic lattice.

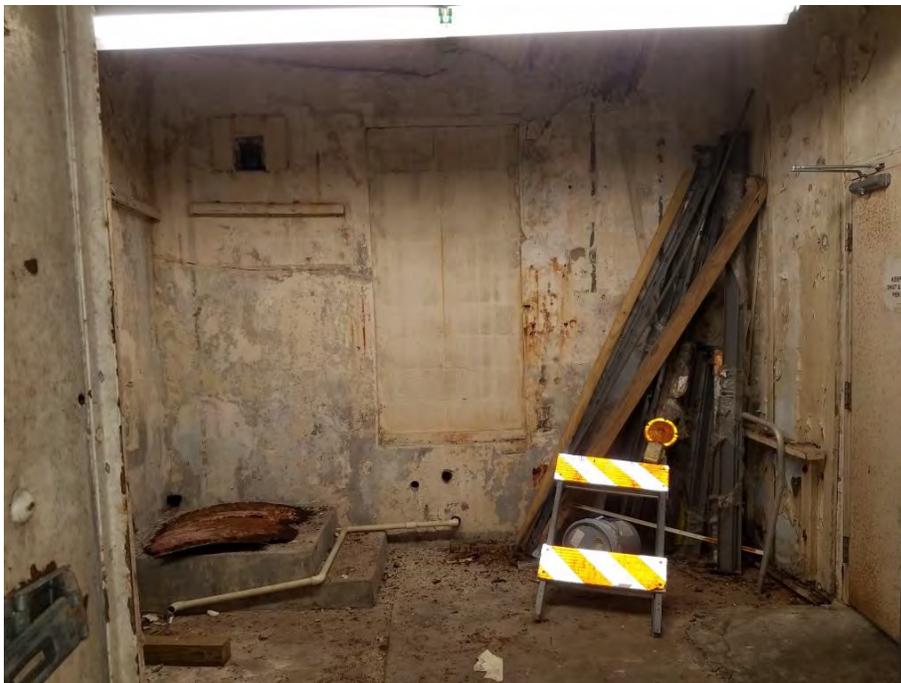
This typical storeroom is located at the first floor, near the east side of the building. The extremely deteriorated finishes consist of concrete flooring, peeling painted plaster, and a corrugated steel ceiling which has completely rusted away in places. Note spalling around the blocked window opening.

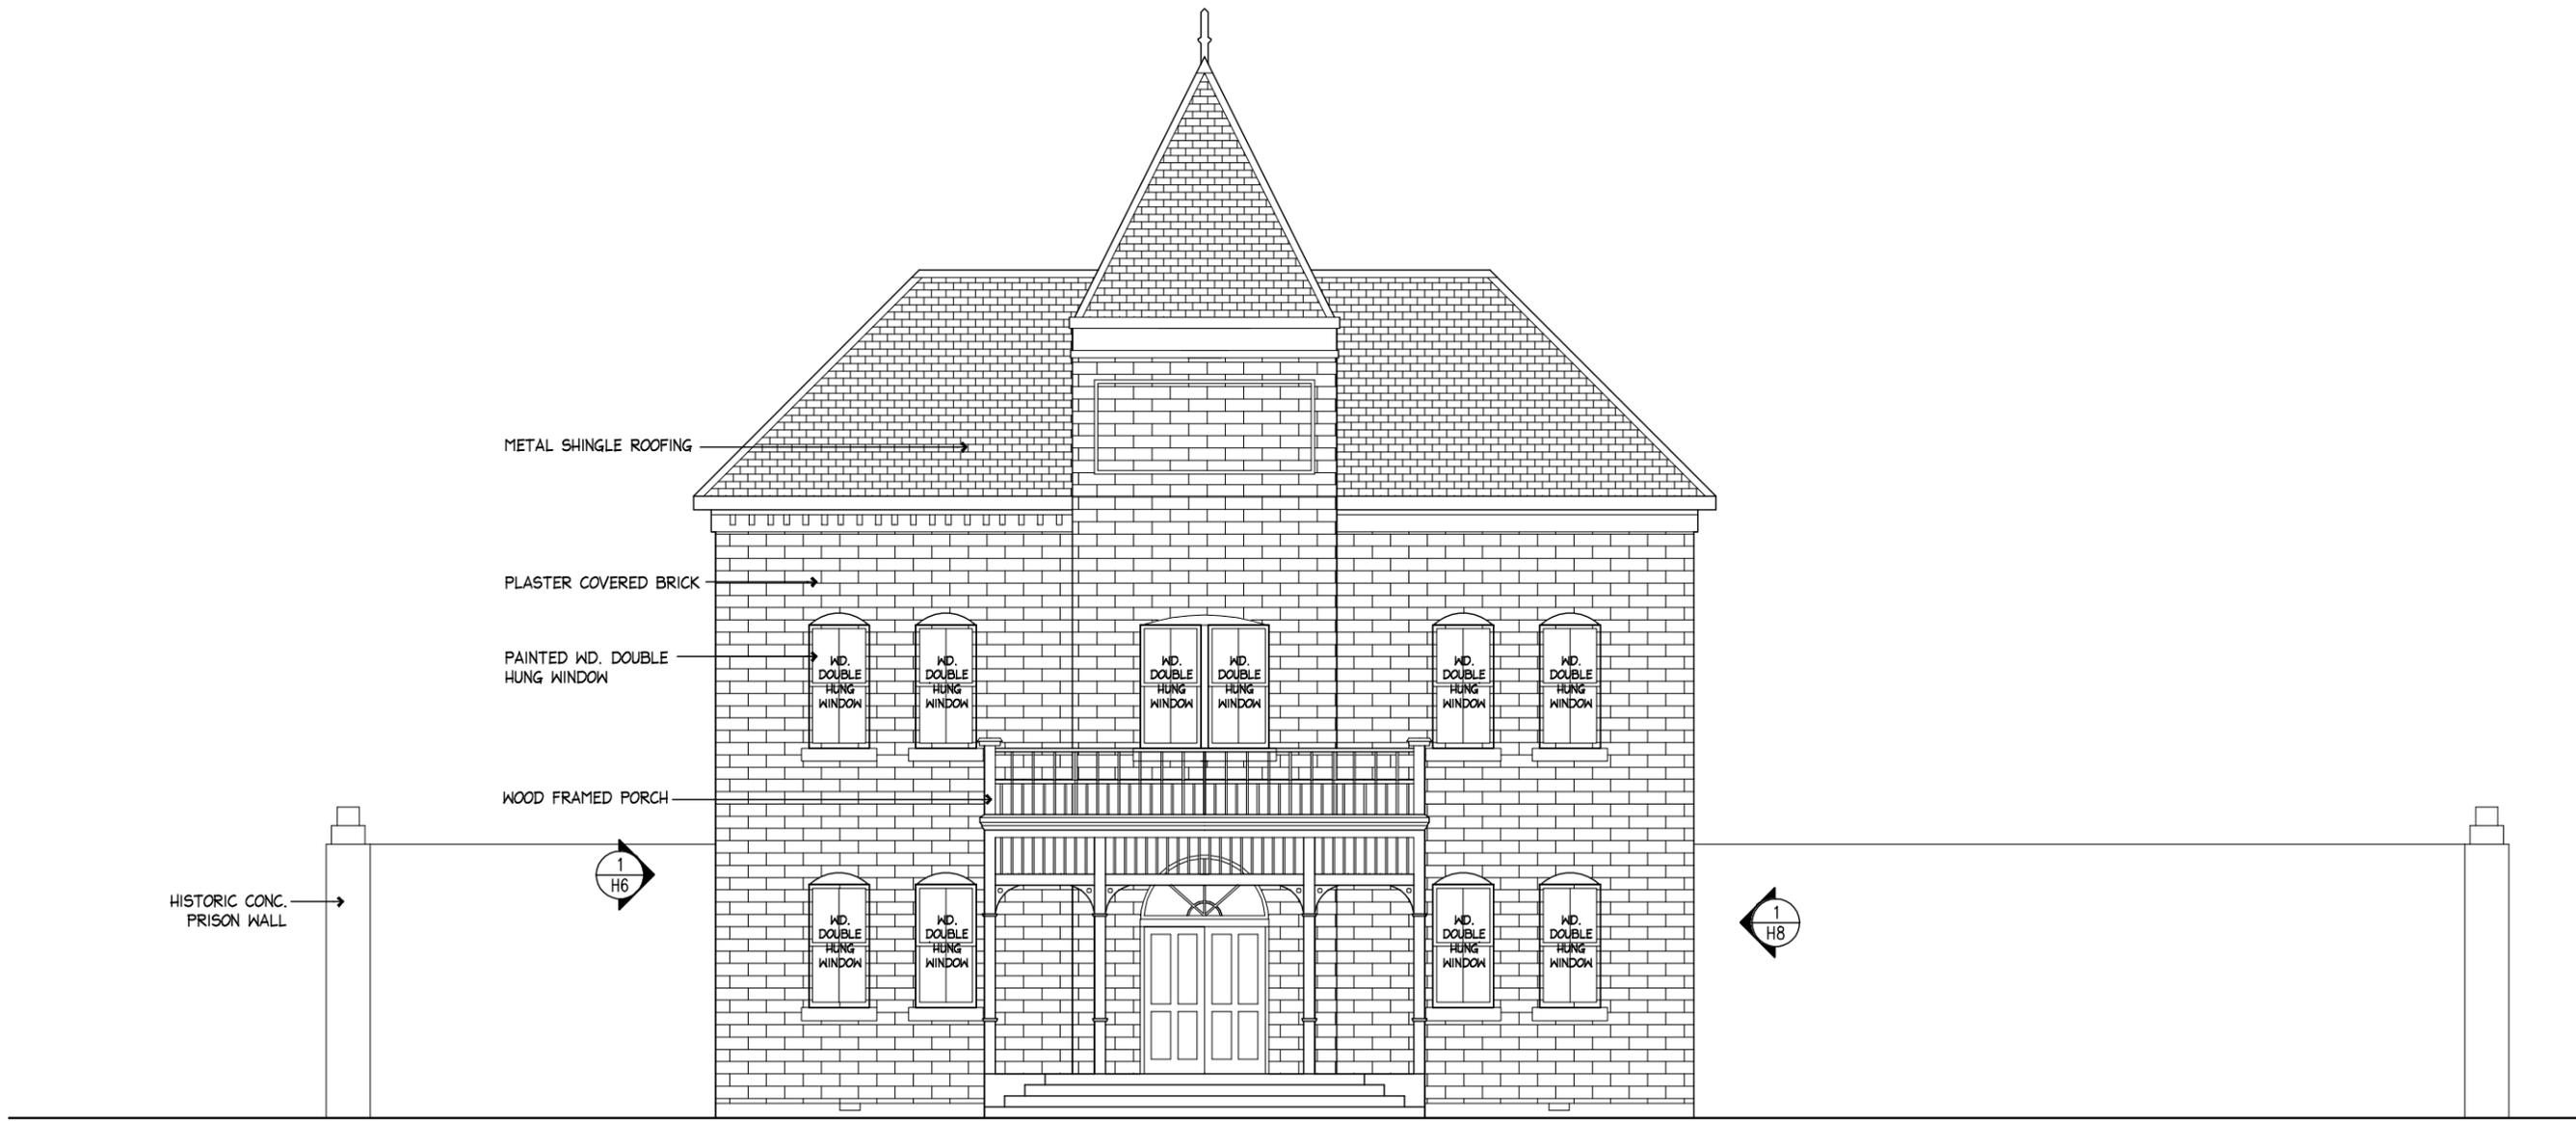
1
H5

PROBABLE HISTORIC EAST (WHITEHEAD STREET) EXTERIOR ELEVATION - CIRCA 1910

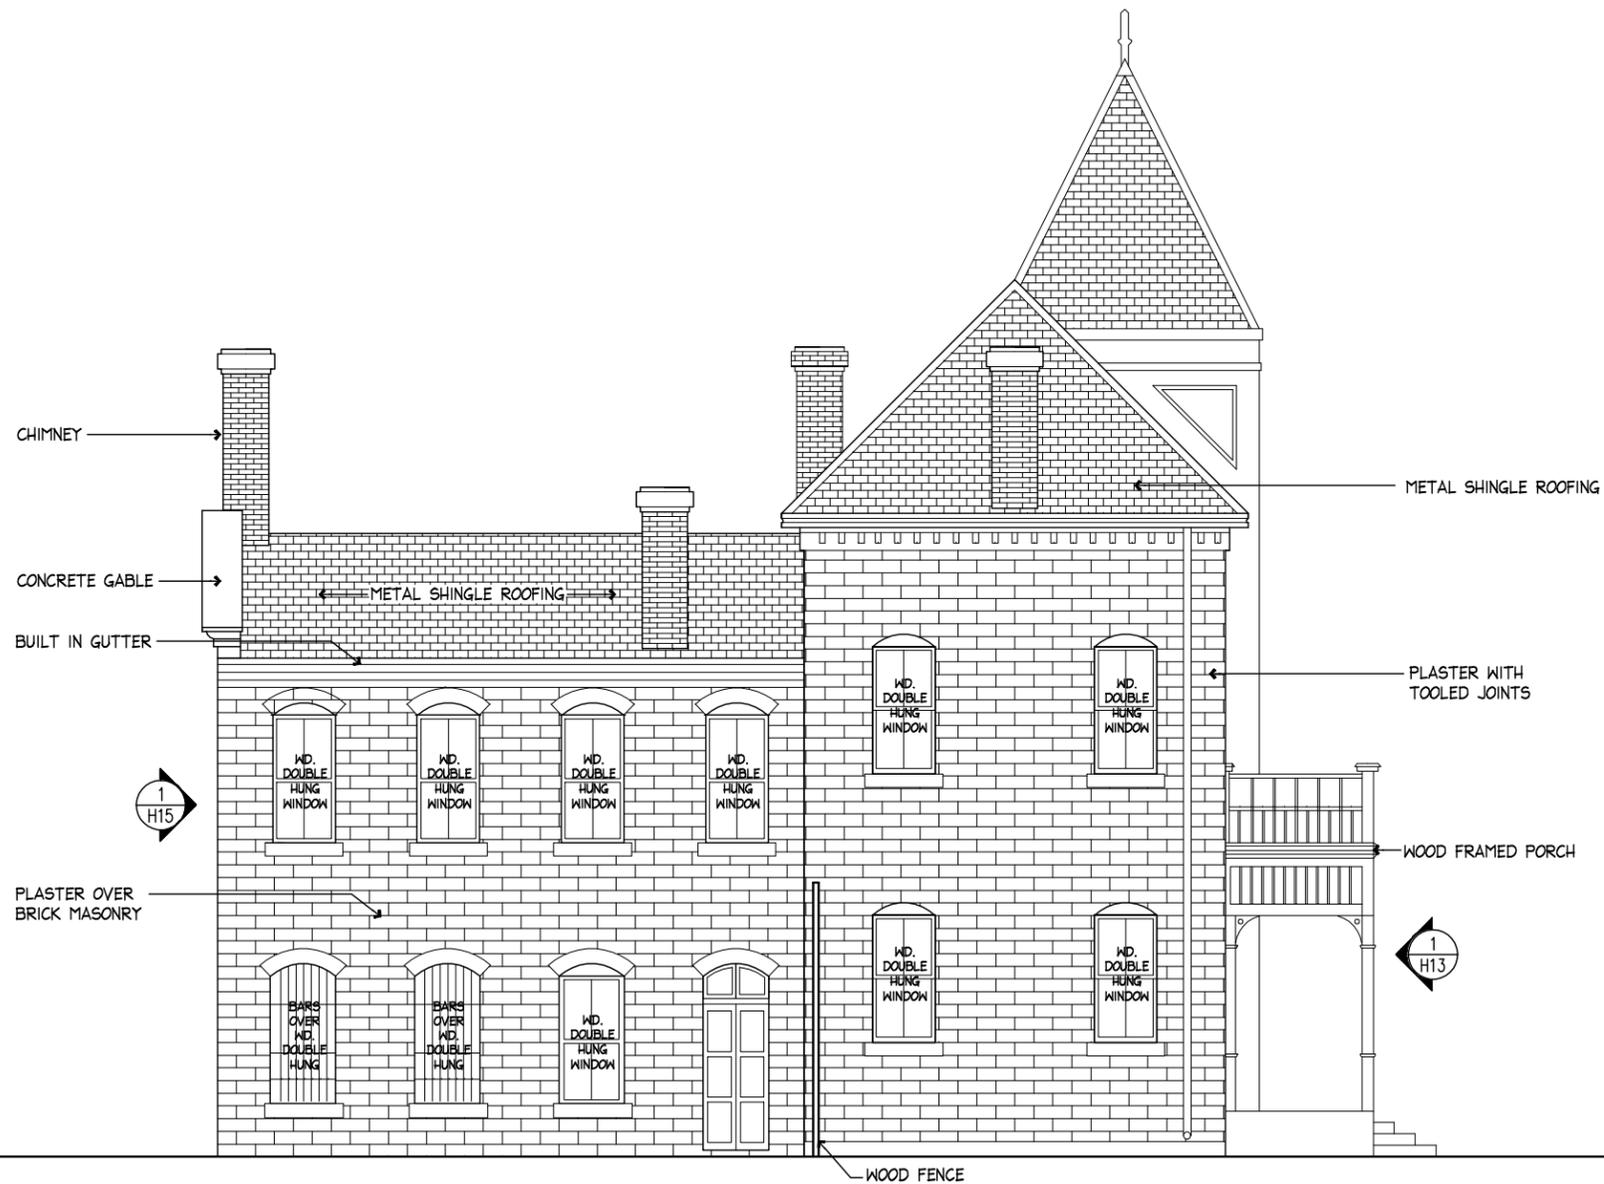
PROBABLE HISTORIC EAST (WHITEHEAD STREET) EXTERIOR ELEVATION - CIRCA 1892
