Appendix B
Field Observation Report

FIELD OBSERVATION REPORT

RE: **FIELD OBSERVATION REPORT FOR THE MOORING FIELD SITE VISITS
RELATIVE TO THE MONROE COUNTY PUBLIC/PRIVATE MOORING FIELD
PROJECT IN THE FLORIDA KEYS, MONROE COUNTY, FLORIDA**

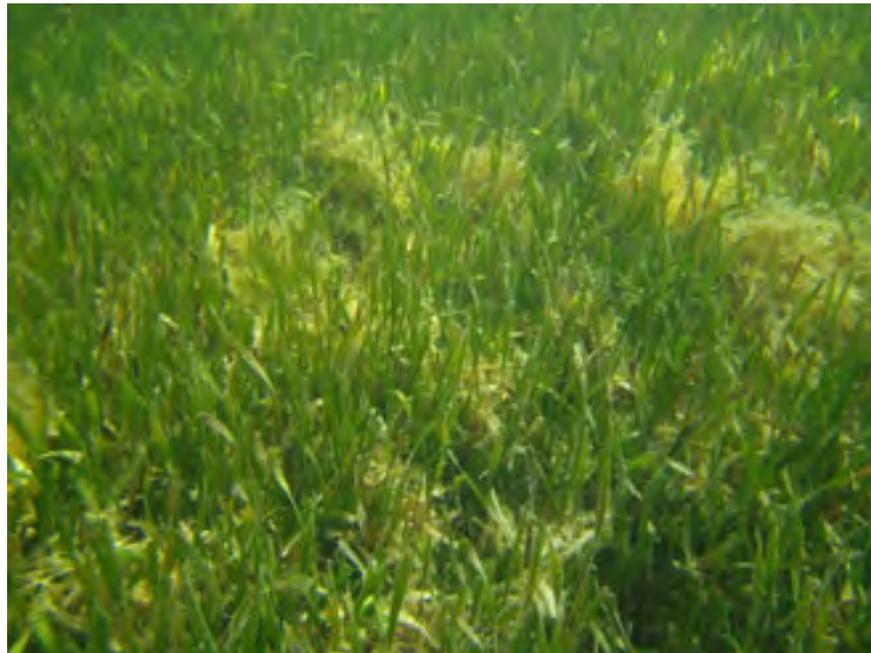
The dominant benthic functional group in the immediate nearshore area of Buttonwood Sound consisted of dense seagrass (Attachment A, Figure 1). Turtle grass (*Thalassia testudinum*) was the dominant species observed in the nearshore area (Photograph 1) and water depths ranged from 2.1 ft to 5.2 ft. The offshore area primarily consisted of patchy seagrass, macroalgae, and sponge. Sparse turtle grass (*T. testudinum*) was the dominant seagrass species observed in the offshore area and water depths ranged from 4.1 ft to 6.5 ft.

Photograph 1: Turtle grass (*Thalassia testudinum*) was the dominant species observed at the Buttonwood Sound site.

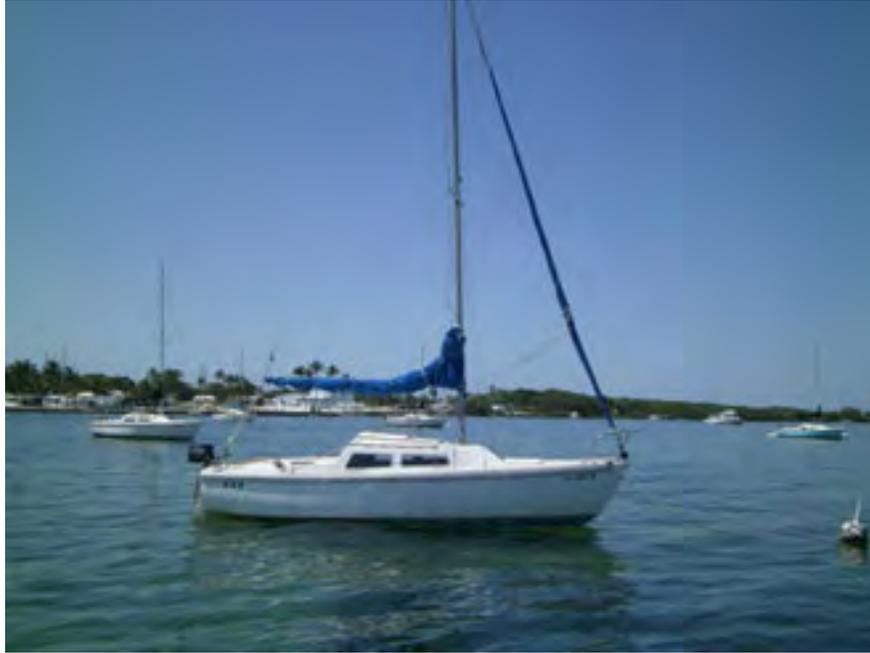
On May 7, 2013, 22 vessels were moored in Buttonwood Sound including 20 sailboats (Photograph 2), one powerboat, one houseboat (Photograph 3), and zero derelict vessels. The sailboats were clustered in the area adjacent to the Upper Keys Sailing Club. The Upper Keys Sailing Club was founded in 1973 and supports the competitive, educational, and social aspects of sailing. A member of the club provided the following information:

Photograph 2: Sailboat observed at the Buttonwood Sound site on May 7, 2013.

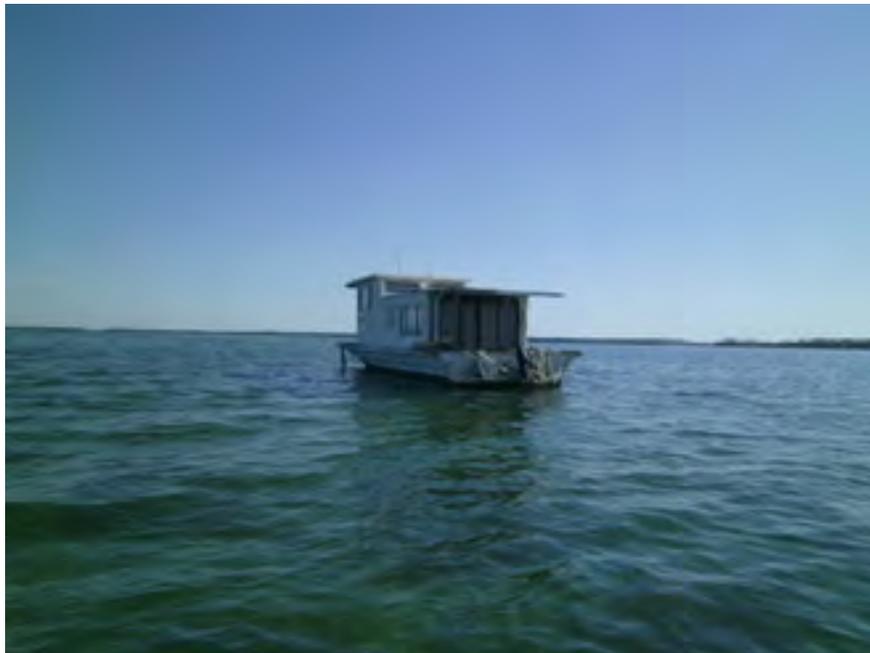
Photograph 3: Houseboat observed at the Buttonwood Sound site on May 7, 2013.

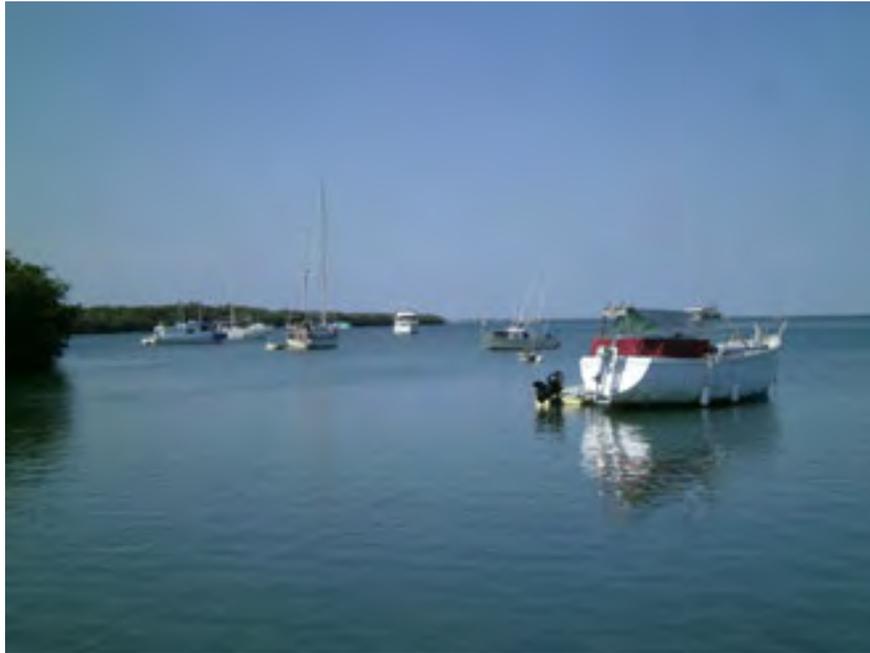
On May 8, 2013, 16 vessels were moored in Jewfish Creek including 10 sailboats, three powerboats, one houseboat, and two derelict vessels. The moored vessels were primarily clustered in the area adjacent to the eastern edge of the channel, south of the Anchorage Resort (Photograph 4). Vessels were also moored under the Overseas Highway Bridge, north of the Anchorage Resort (Photograph 5).

Photograph 4: Vessels observed at the Jewfish Creek site on May 8, 2013.

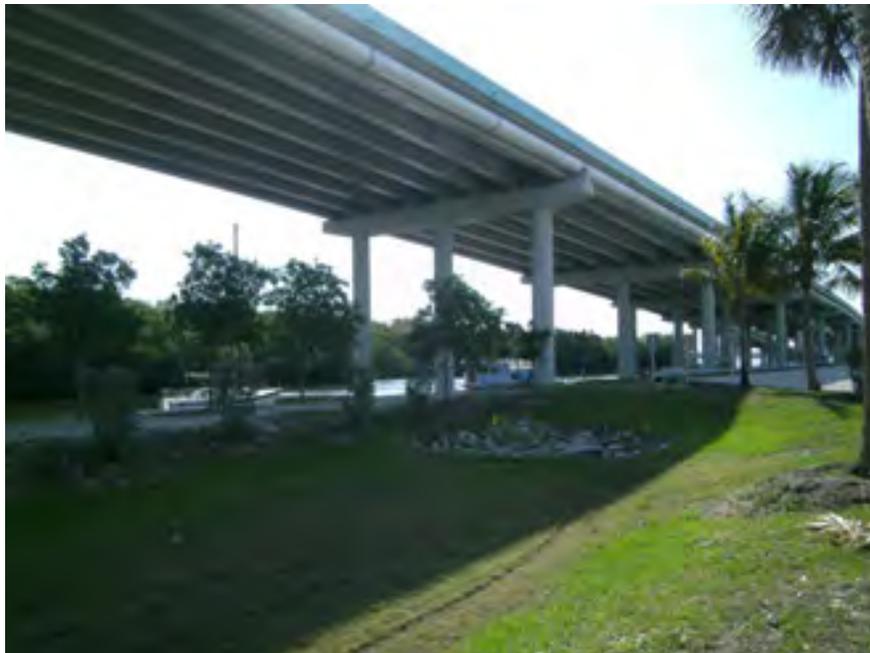
Photograph 5: Vessels moored under the Overseas Highway Bridge, north of the Anchorage Resort on May 8, 2013.

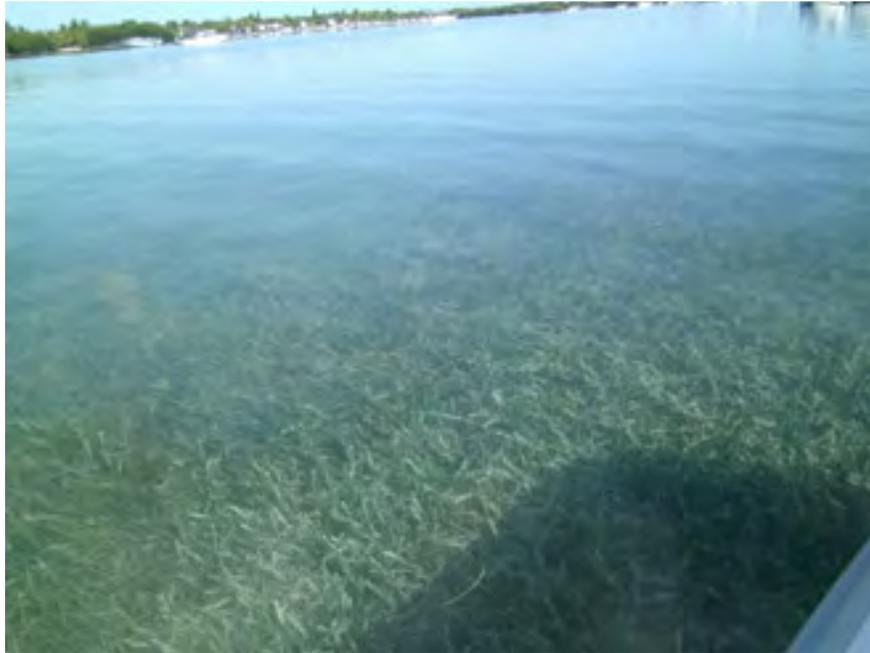
The dominant benthic functional group in the northernmost area of the Boca Chica Site consisted of dense seagrass (Attachment A, Figure 3). Turtle grass (*T. testudinum*) was the dominant species observed in this area (Photograph 6) and water depths ranged from 1.2 ft to 8.9 ft (excluding the channel where depths were up to 18.6 ft). The middle of the site adjacent to the Boca Chica Marina consisted of dense seagrass and hardbottom directly offshore, with sparse seagrass and macroalgae further offshore intermixed among the mangroves. Turtle grass (*T. testudinum*) was the dominant seagrass species observed in these two areas and water depths ranged from 1.4 ft to 8.5 ft.

Photograph 6: Turtle grass (*Thalassia testudinum*) was the dominant species observed at the Boca Chica site.

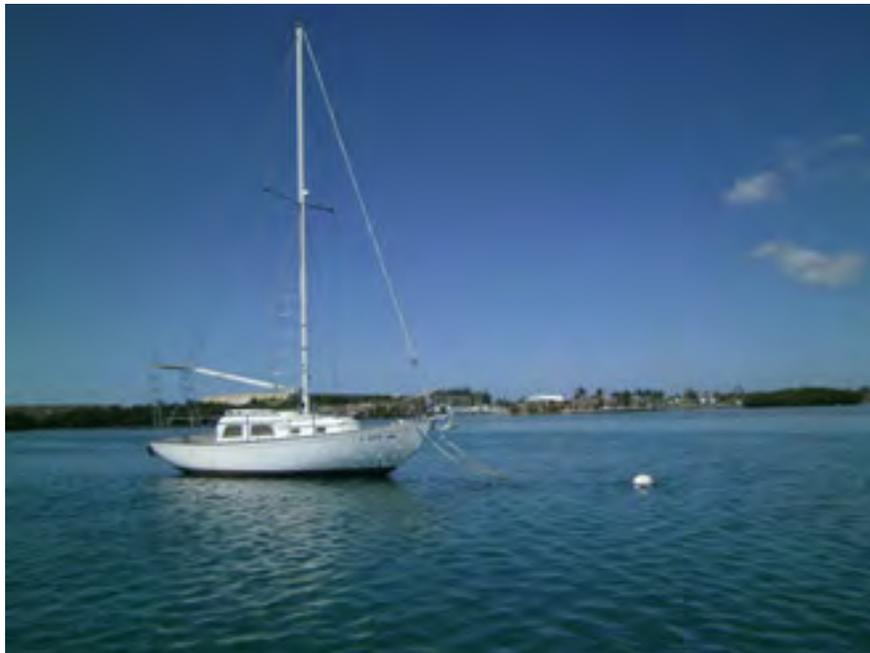
On May 6, 2013, 62 vessels were moored in Boca Chica including 19 sailboats (Photograph 7), 25 powerboats, five houseboats (Photograph 8), and 13 derelict vessels (Photograph 9). The moored vessels were primarily located in the northern portion of the site. An individual who resides on a sailboat in the Boca Chica site provided the following information:

Photograph 7: Sailboat observed at the Boca Chica site on May 6, 2013.

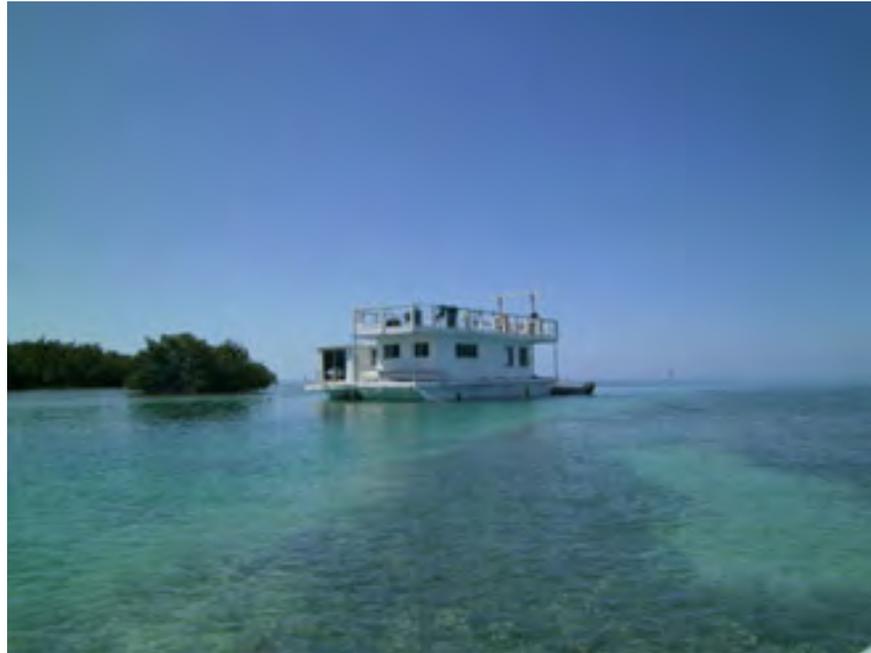
Photograph 8: Houseboat observed at the Boca Chica site on May 6, 2013

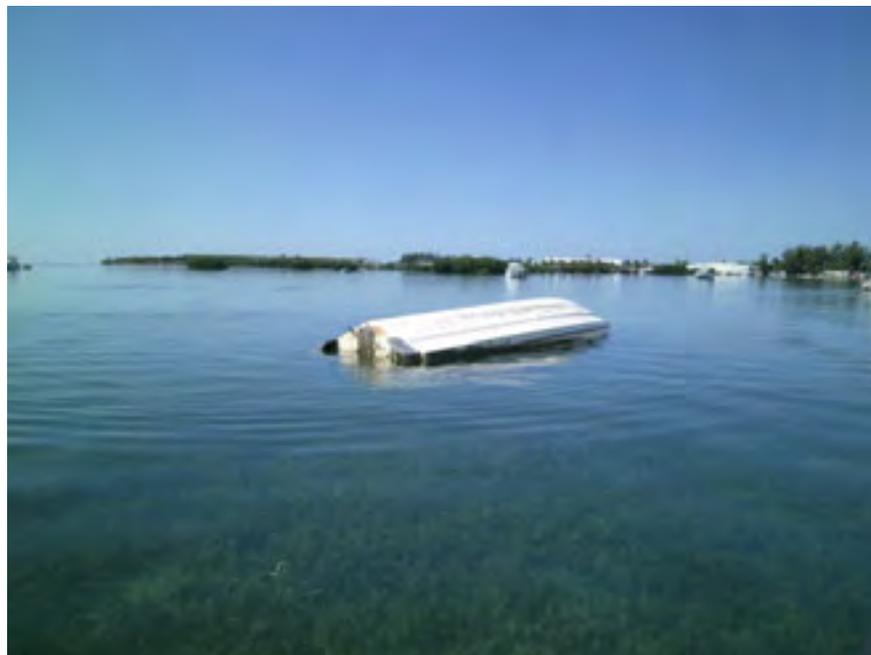
Photograph 9: Overturned derelict vessel observed at the Boca Chica site on May 6, 2013.
